Eastview Landfill 2022 Annual Report

Prepared by:

TETRA TECH

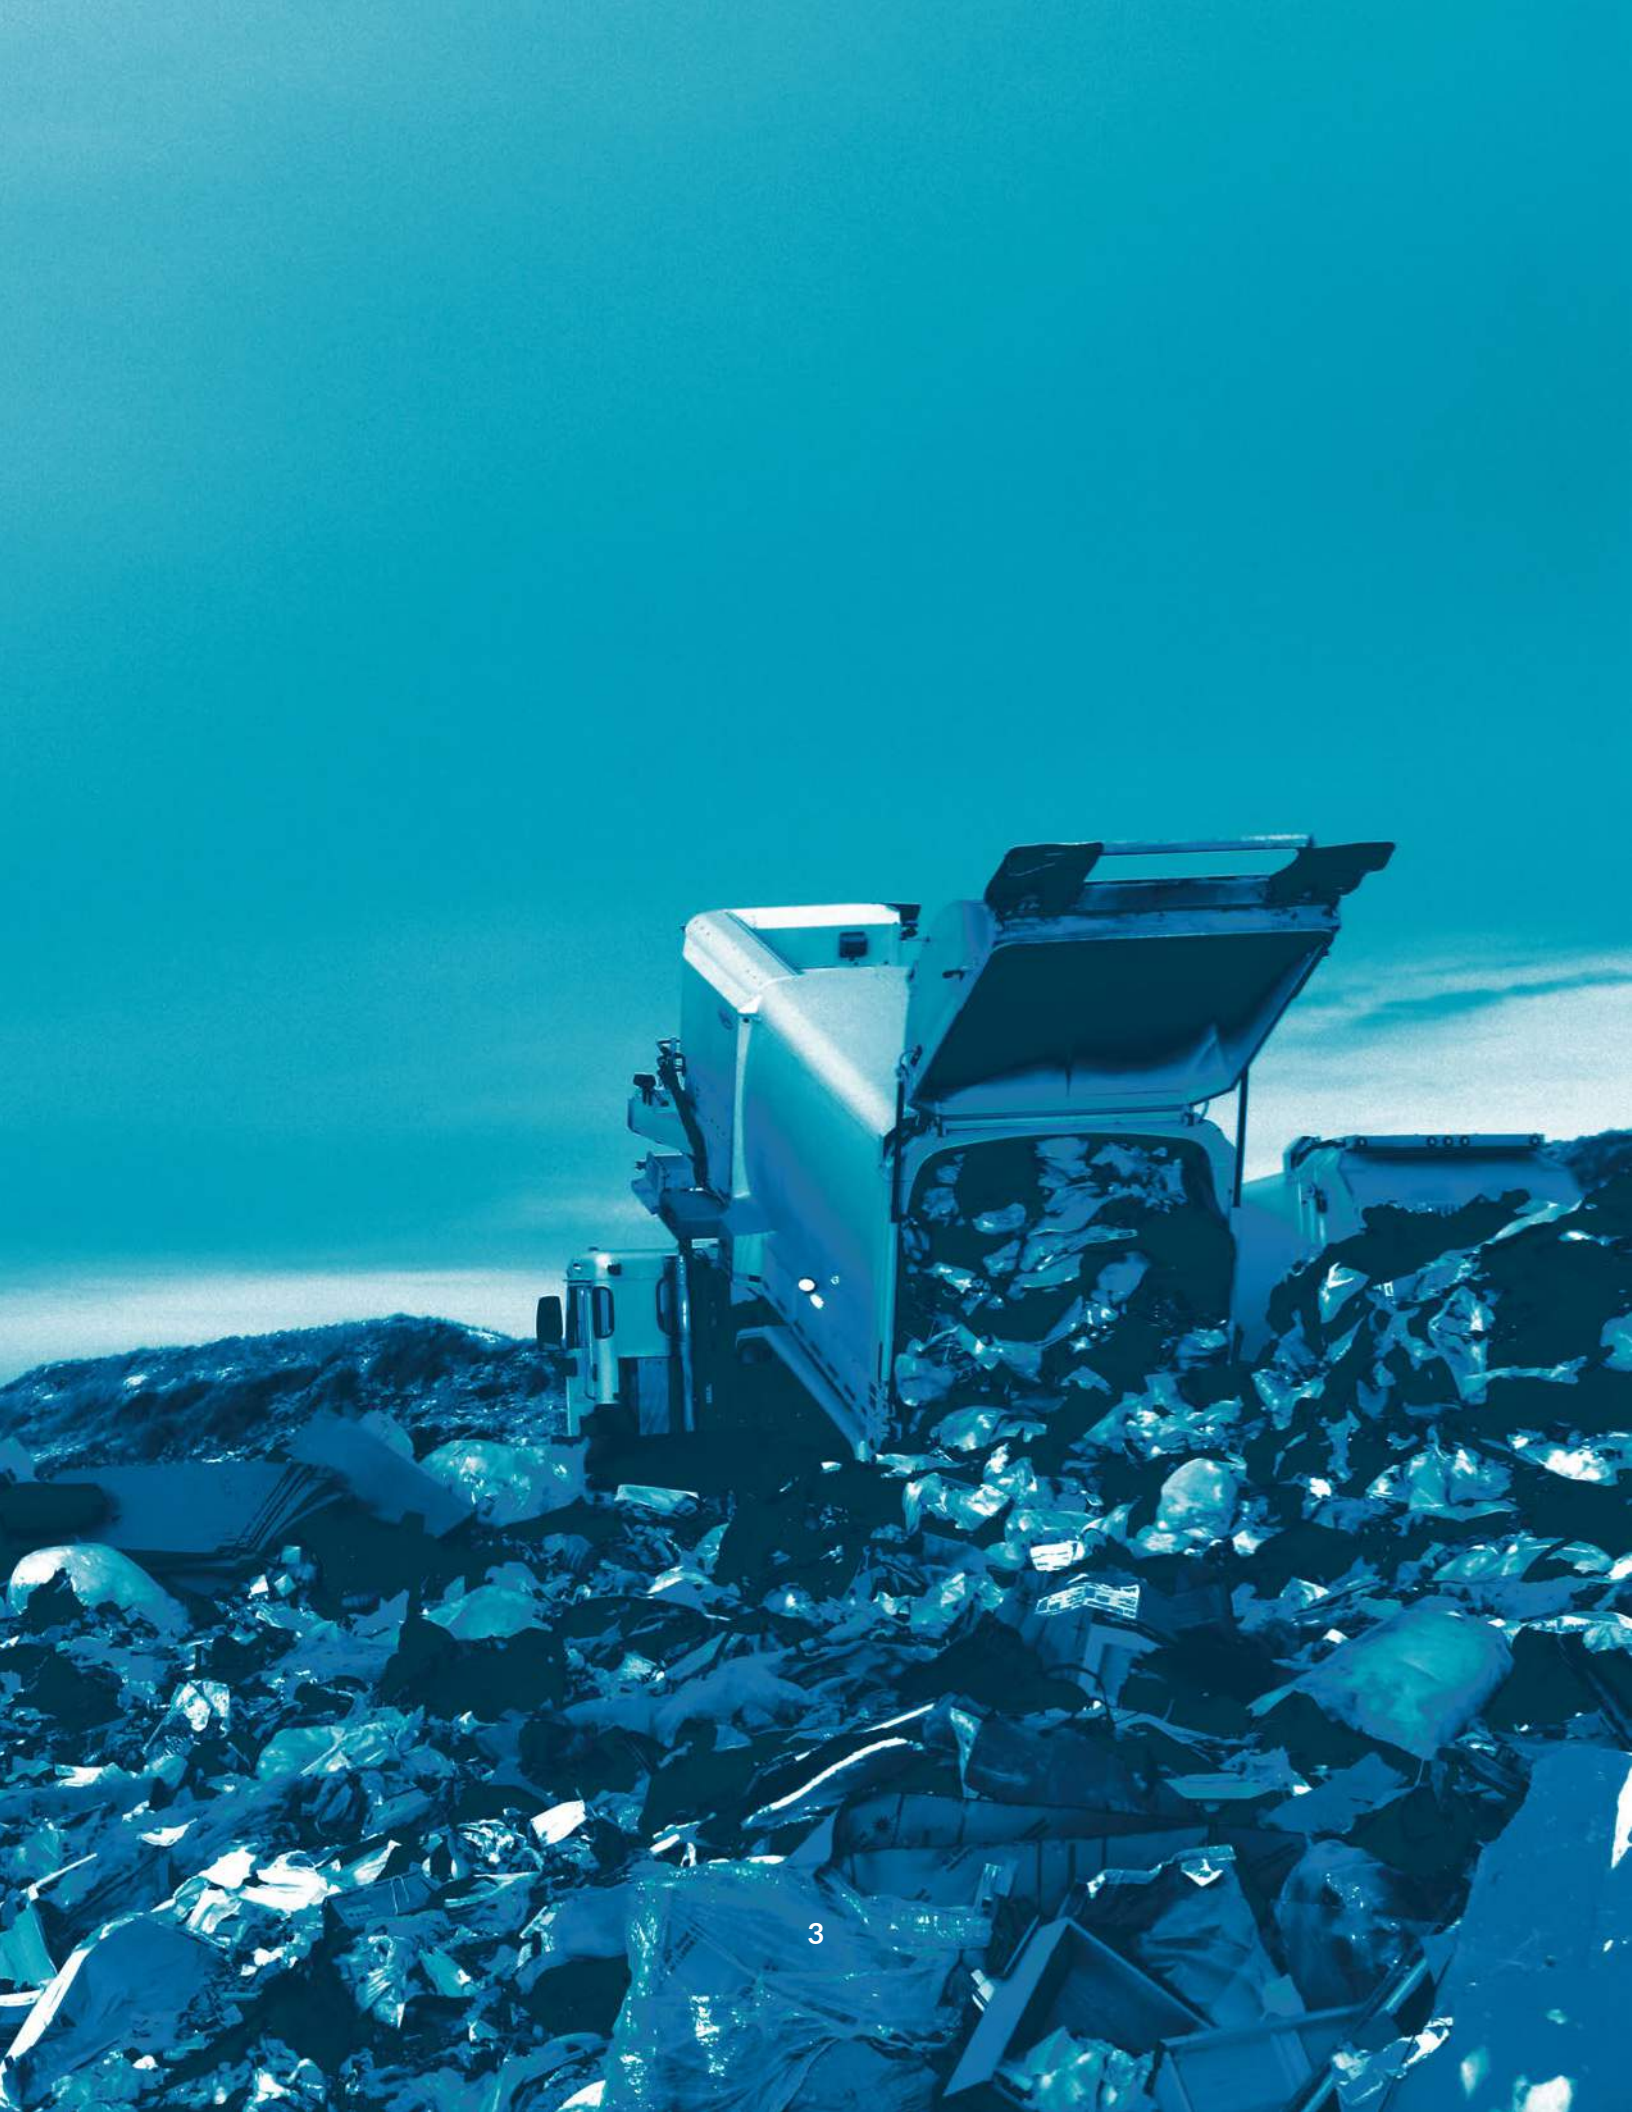
The areas of the Landfill are shown in Figure E-1.

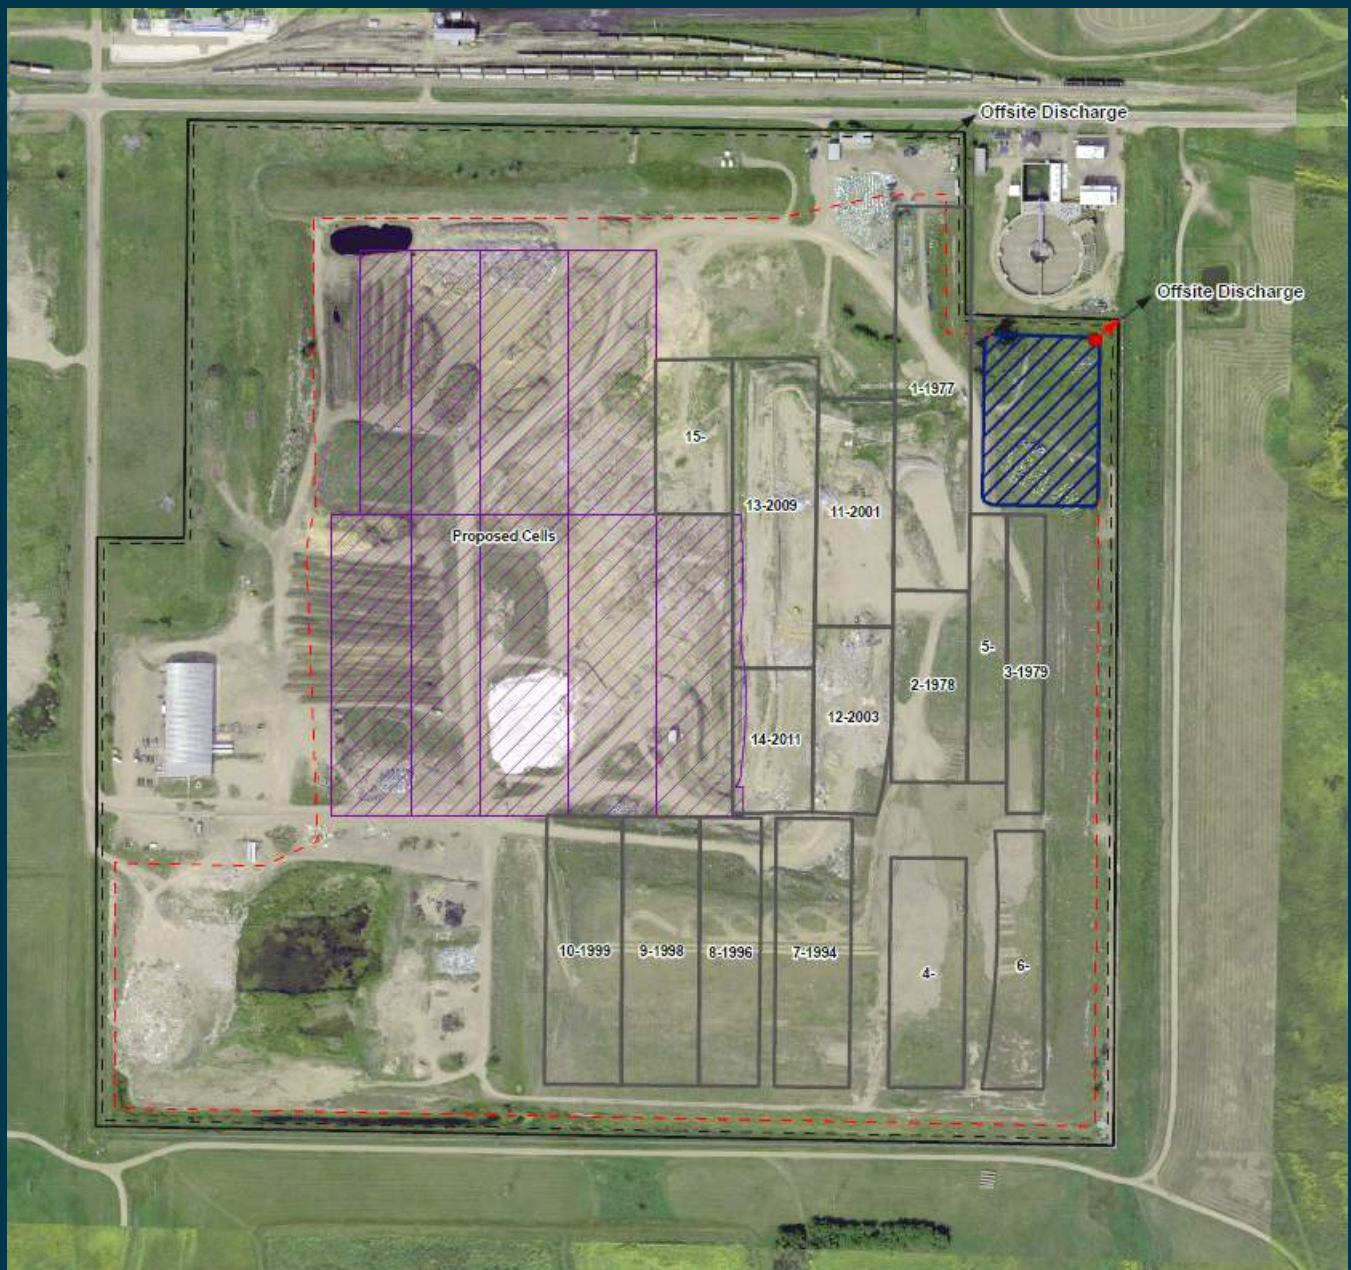
Figure 2: Landfill Cell Design Master Plan (KGS Group 2017)

The following summarizes the developed and undeveloped areas within the Landfill design footprint, also shown on the KGS Group Landfill Cell Design Master Plan, shown as Figure 2.

- Cell 1 to Cell 6 – Developed along the eastern edge of the Landfill, unlined cells from the 1970s and 1980s that have been closed and capped.
- Cell 7 – Developed in 1994, a Geosynthetic Clay Liner that has been closed and capped.
- Cell 8 to Cell 12 – Developed between 1996 and 2003, High-Density Polyethylene (HDPE) lined cells that have been closed and capped.
- Cell 13 to Cell 16 – Developed between 2009 and 2017, HDPE lined cells that are currently in use.

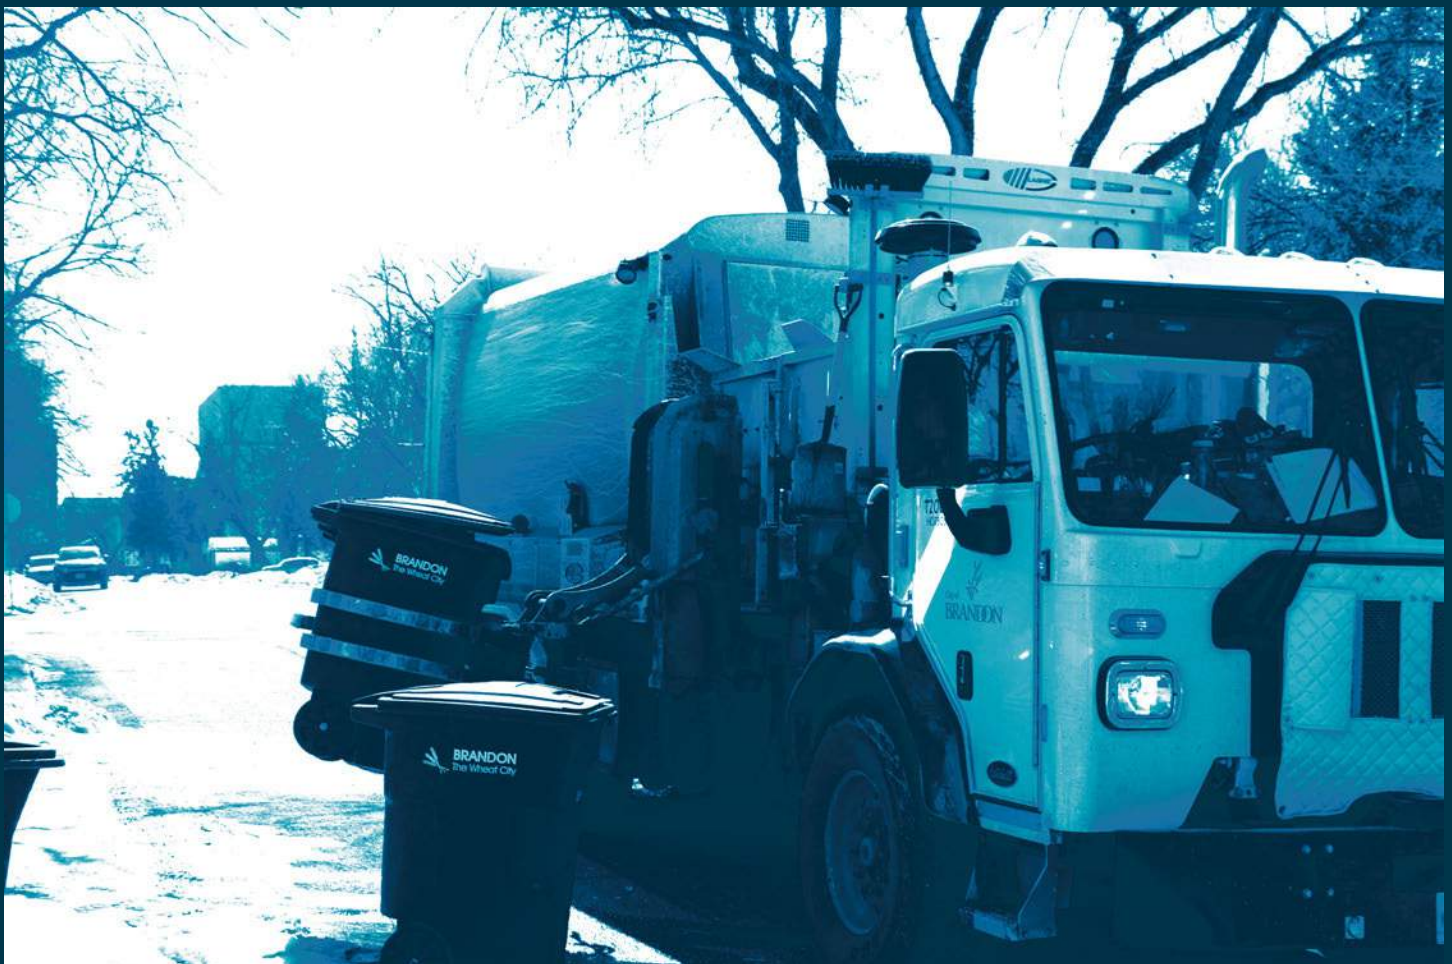
Table 3-2: Waste Disposed in the Eastview Landfill Annually

Materials (Tonnes)	2019	2020	2021	2022
Asbestos	168.87	231.98	305.03	74.12
Commercial Mixed Refuse	17,675.40	14,161.82	17,573.40	19,065.29
Residential Mixed Refuse	2,554.44	2,075.56	1,465.76	1,149.81
City Curbside Collection	9,921.21	10,918.29	10,815.32	10,024.82
Wastewater Treatment Facility Sludge	506.55	499.67	528.38	1,339.43
Total	30,826.47	27,887.32	30,687.89	31,653.47

Table 3-2 shows materials disposed in the Landfill from 2019 to 2022.

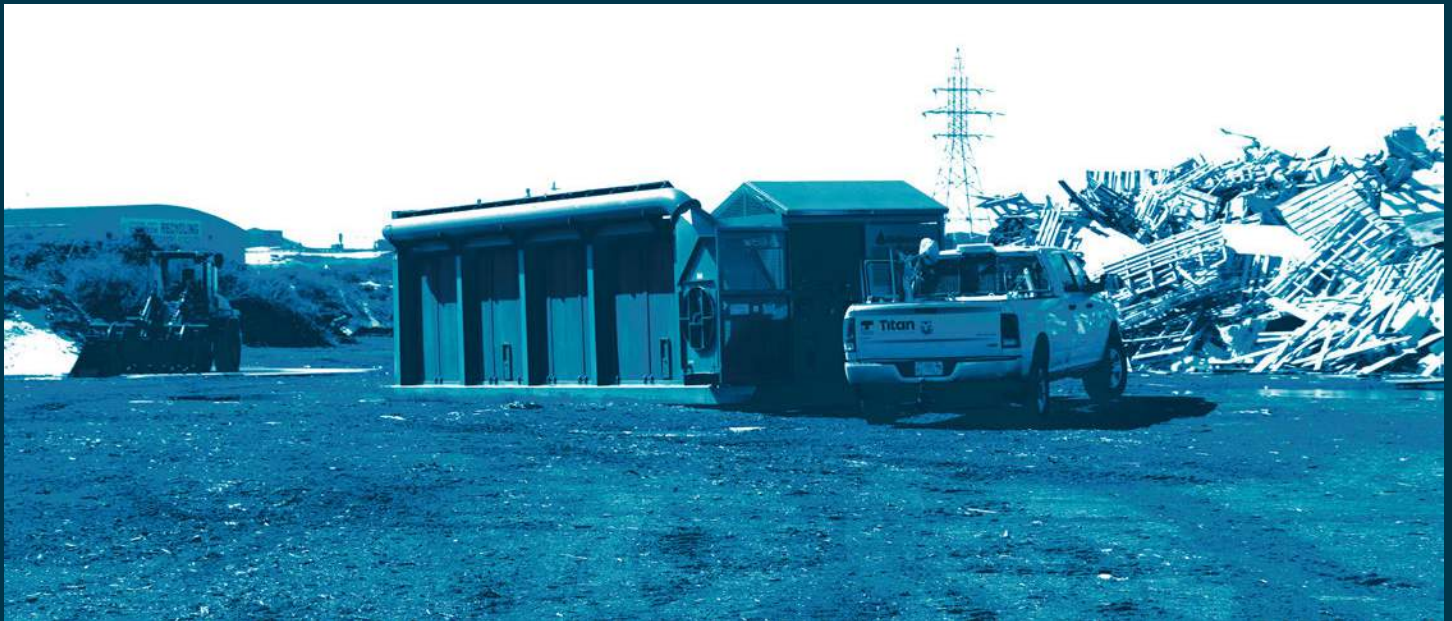
Table 3-2 Comparison of Collection Methods for Organic Materials

Material (tonnes)	2019	2020	2021	2022
Depots	400.79	423.74	381.53	313.76
Self-Haul	329.17	401.34	268.58	238.06
Curbside	2,119.34	2,231.47	1,988.94	2,219.42
Total	2,849.30	3,056.55	2,639.05	2,771.24

Table 3-3 depicts the collection of diverted organic materials between depot, self-haul, and curbside collection over the past four years. Curbside collection by the City remains the primary source of diverted organic materials.

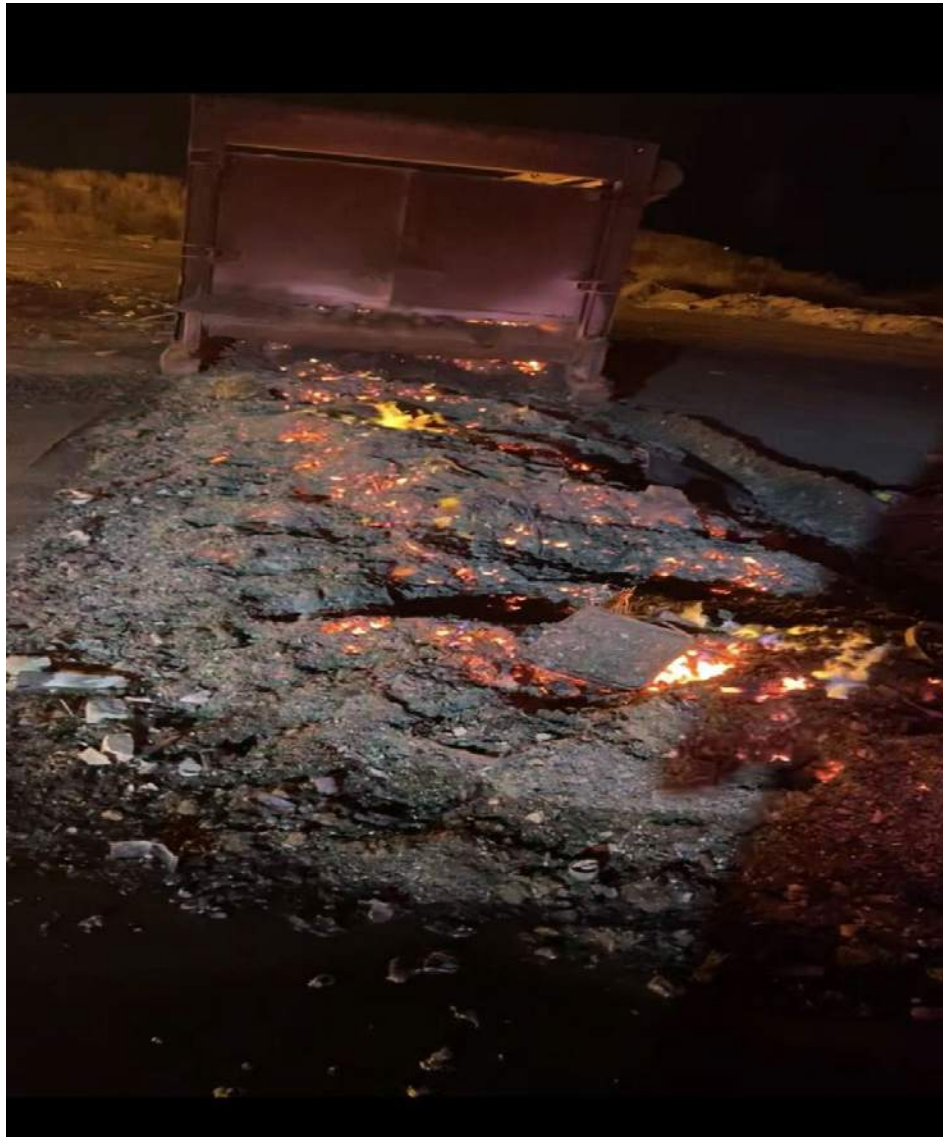
On November 3, 2022 there was an unplanned fire within the burnable wood pile. The fire was likely the result of the 2022 wood incineration project. The fire was assumed to be started by embers from the wood incinerator that were not completely extinguished before the contractors' staff left the Landfill for the evening. The City Sanitation Department administration was notified by 911 at approximately 7:30 p.m. that a fire was happening on site and that fire fighters were requesting assistance of Landfill operators and equipment. The Brandon Fire and Emergency Services (BFES) determined that the fire would be a controlled burn and requested that the wood and yard waste located nearby be moved and that a fire break be constructed on the west berm to mitigate the spread of any further fire along a nearby grassy area. After the material was moved to a safer location, BFES left two units and staff to monitor the area. One operator from the City Sanitation Department remained on site to operate equipment if needed.
