City of Brandon

1st and Rosser Site Remediation Closure Report, Brandon, Manitoba

60116296 (100138)

February, 2010

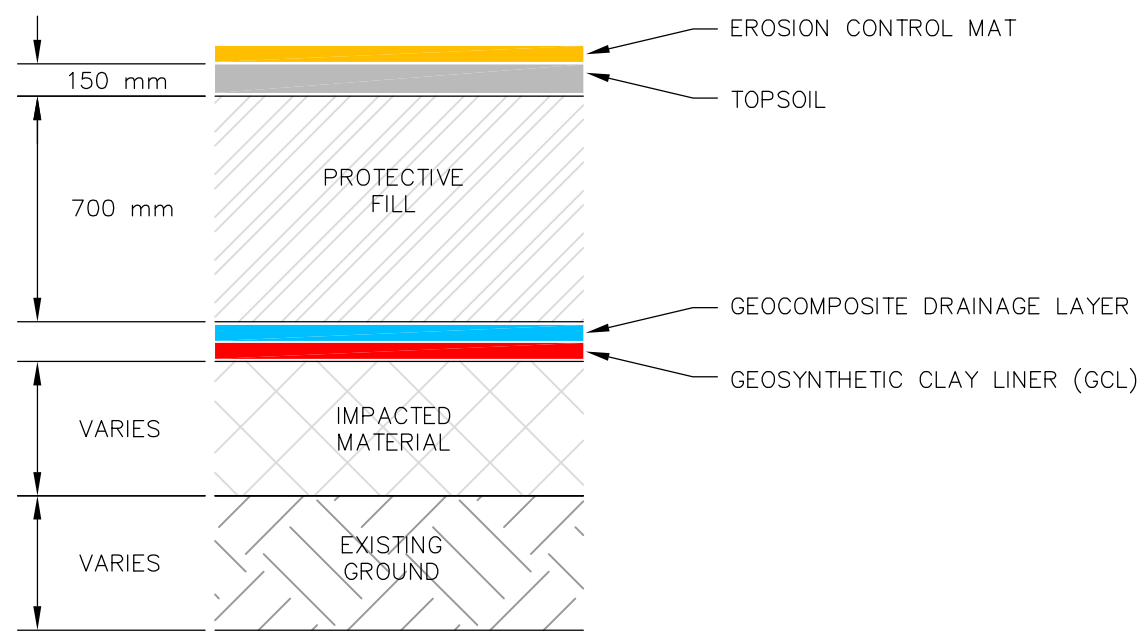
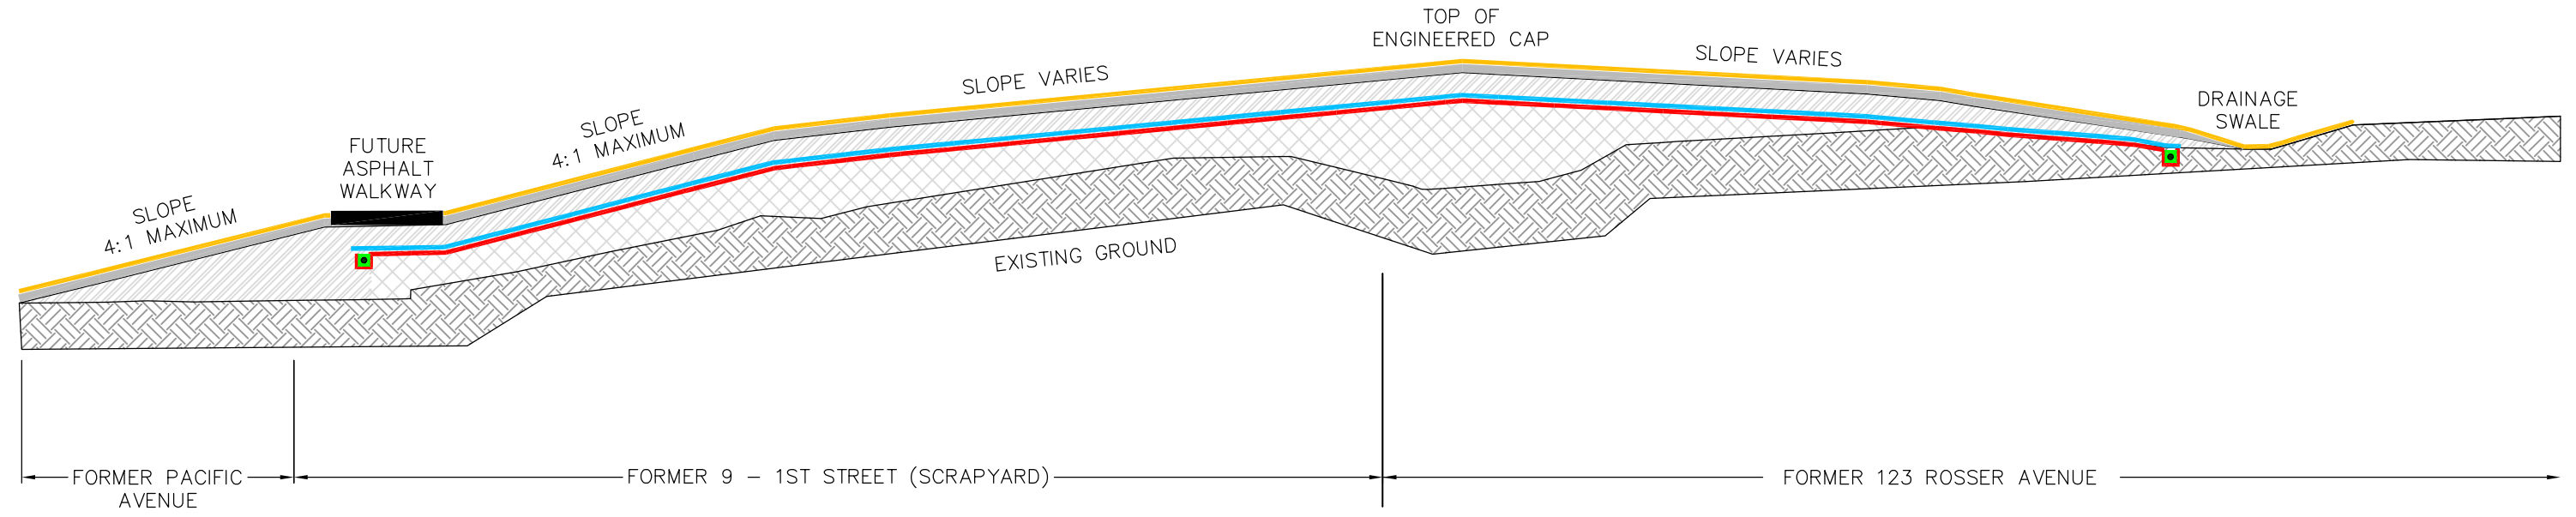
- PERIMETER SUBDRAIN
- EXISTING GROUND
- IMPACTED MATERIAL
- PROTECTIVE FILL LAYER
- TOPSOIL LAYER
- GEOSYNTHETIC CLAY LINER (GCL)
- GEOCOMPOSITE DRAINAGE LAYER
- EROSION CONTROL MAT

- A geosynthetic clay liner (GCL) was installed to prevent infiltration of water and air. The GCL consisted of a uniform layer of bentonite encapsulated between two non-woven geotextiles reinforced with a woven scrim. The GCL was needle-punched to enhance the frictional and internal shear strength characteristics. It was installed over an area of 11,000 m² in panels parallel to the slope and overlapped on each side according to design specifications.

- A protective fill layer was placed over the drainage layer to provide physical separation between the metals impacted material and the final grade, and to provide some protection for the underlying GCL layer from frost penetration. A minimum protective fill thickness of 0.70 m, confirmed by GPS survey, was placed over all areas to protect the GCL.

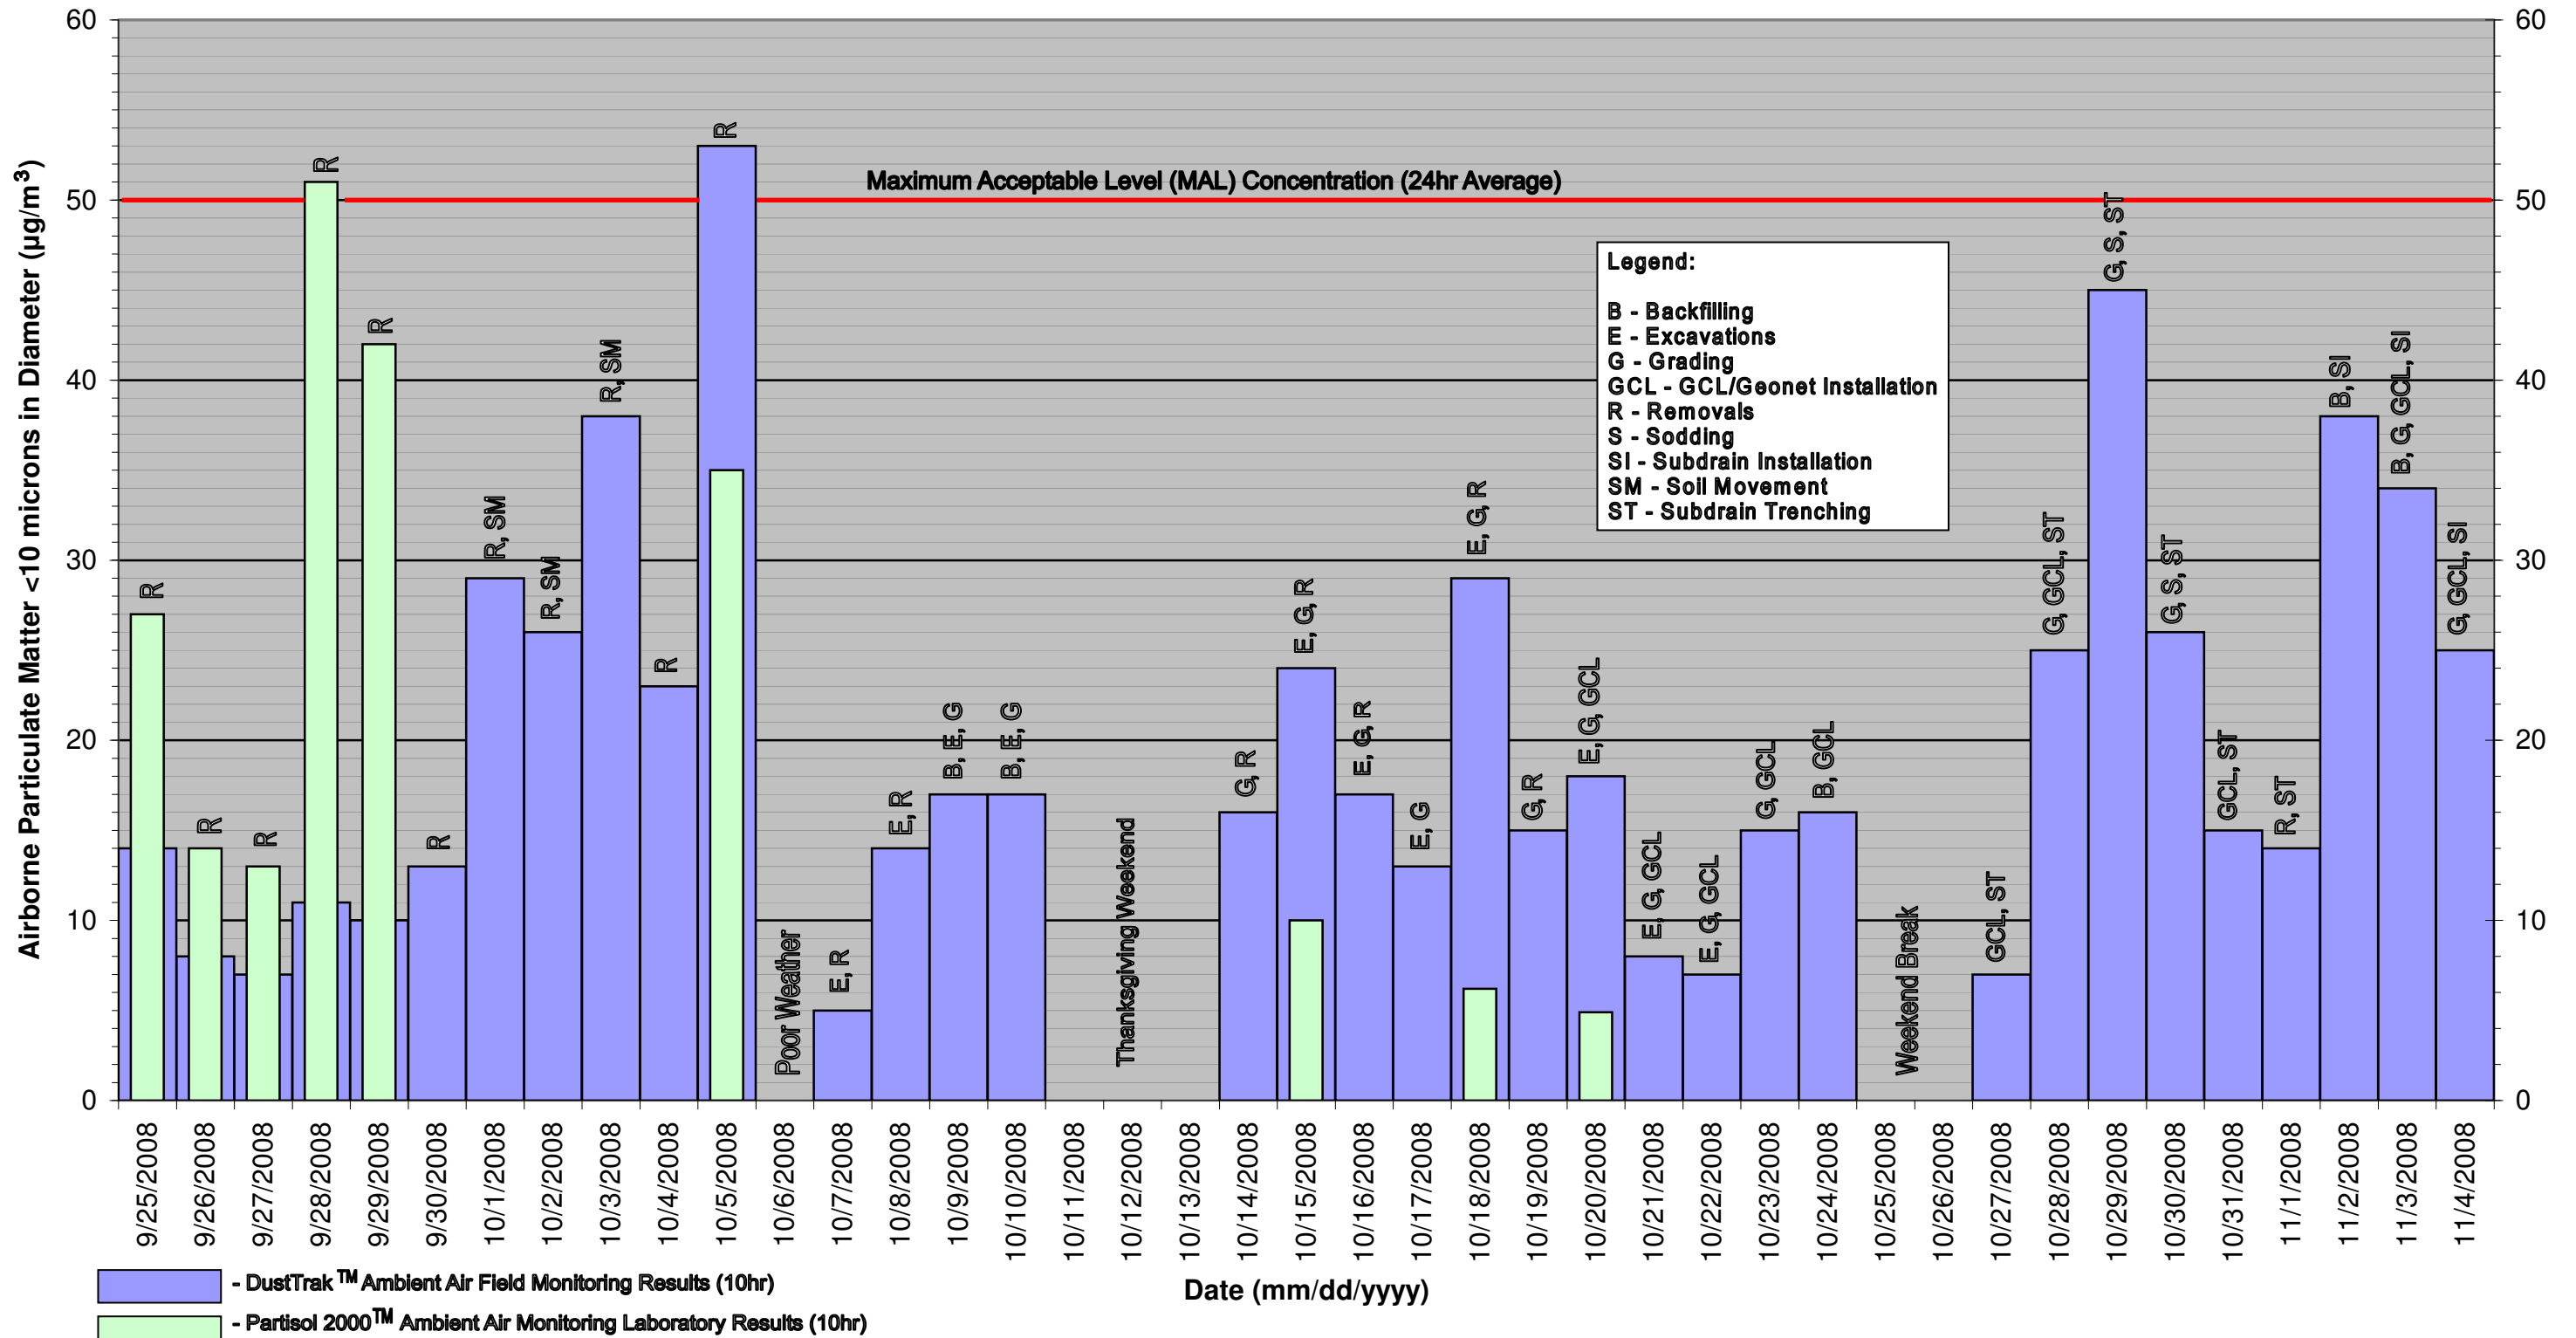
Figure 13. Average Ambient Air Quality Monitoring Results (PM₁₀)

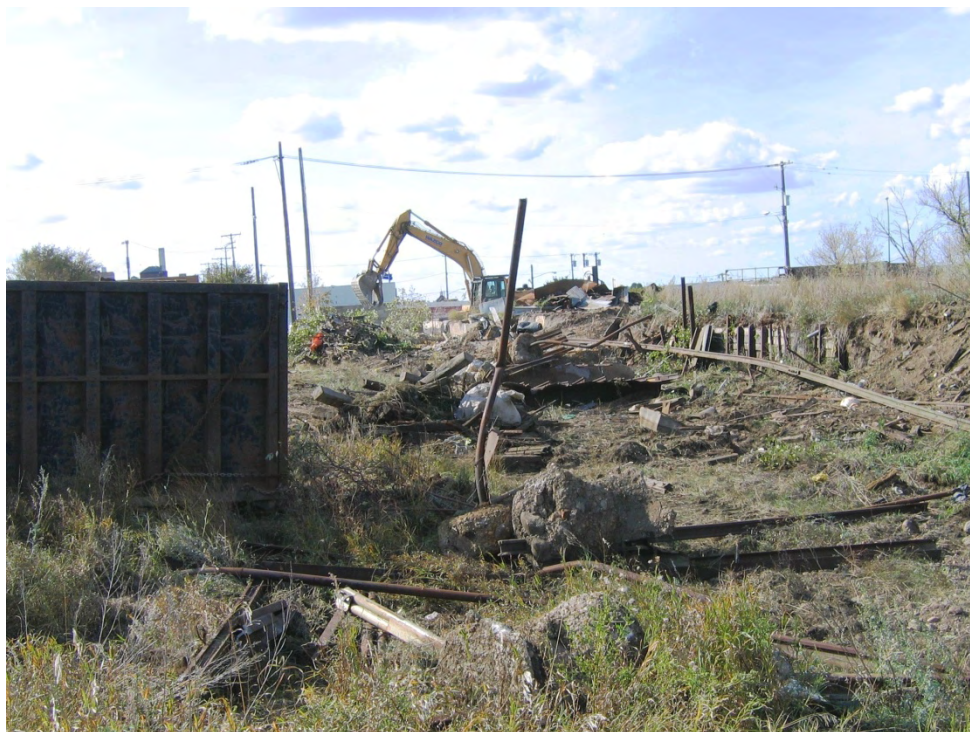
Photograph 1. Clearing site debris. Photograph facing west. (September 2008)

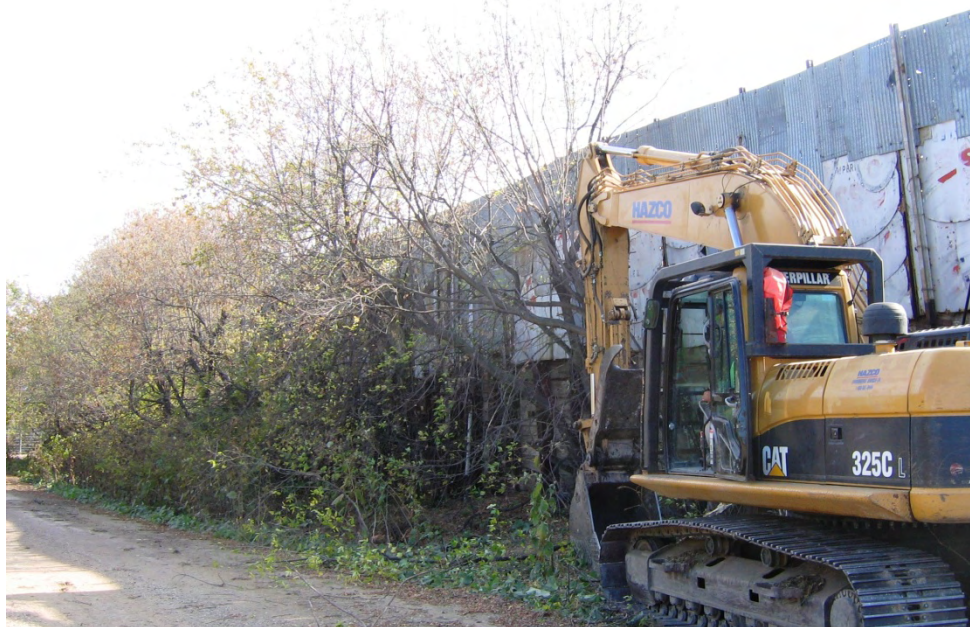
Photograph 2. Clearing trees north of scrap yard fence. Photograph facing southeast (September 2008)

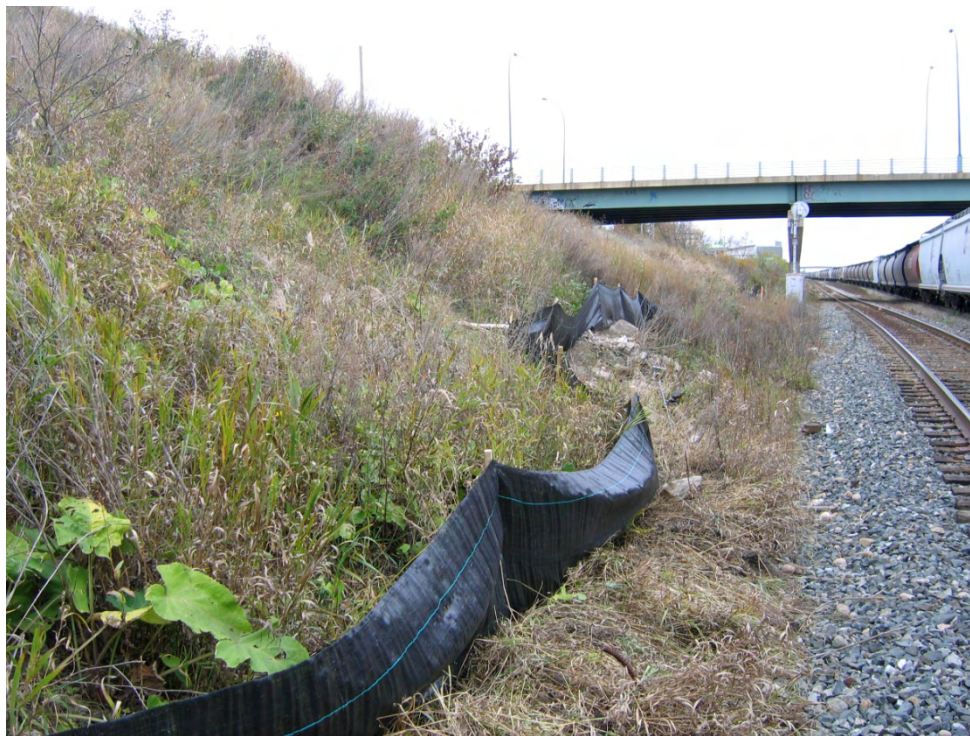
Photograph 3. Silt fence installed north of Pacific Avenue prior to construction activities. Photograph facing west. (September 2008)

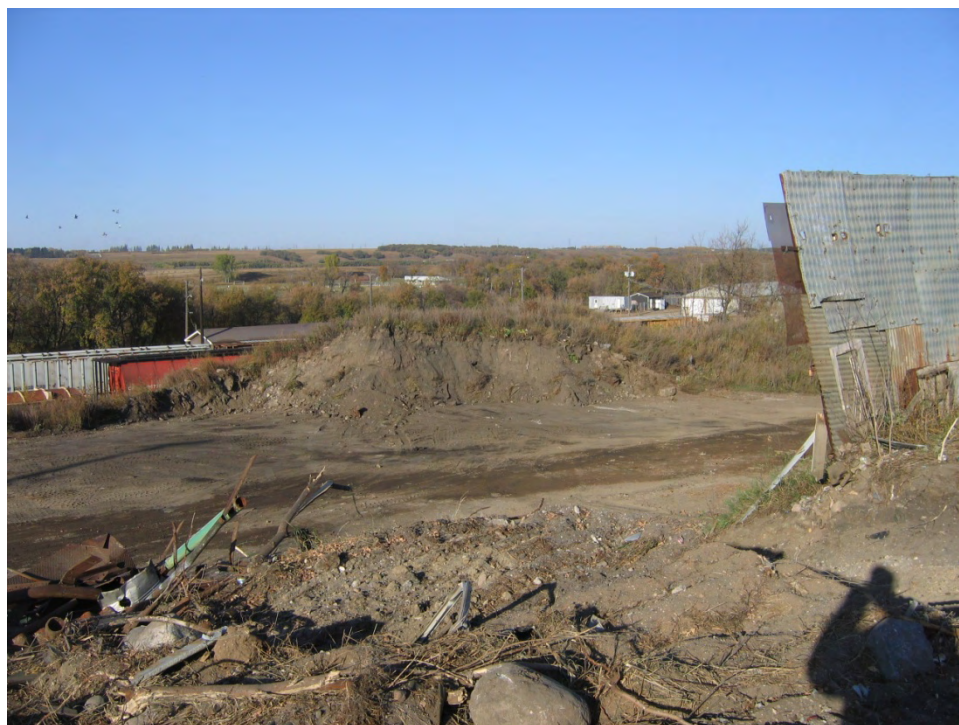
Photograph 4. Moving soil stockpile north of Pacific Avenue. Photograph facing northeast. (October 2008)

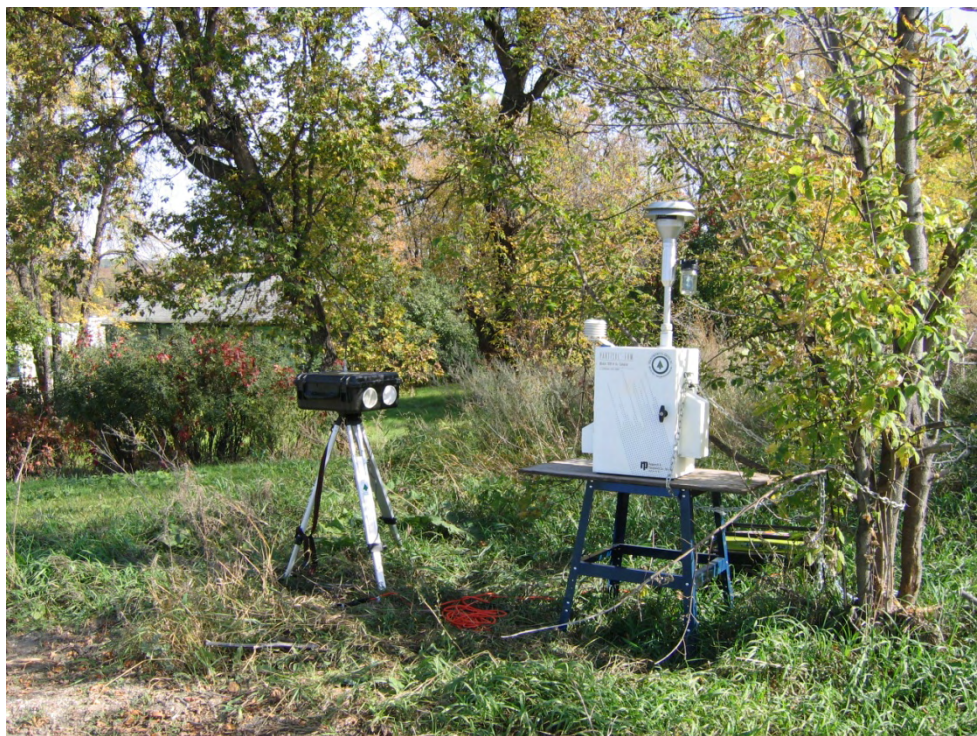
Photograph 5. Air quality monitoring station 1, east of Russell Street. Photograph facing northeast. (October 2008)

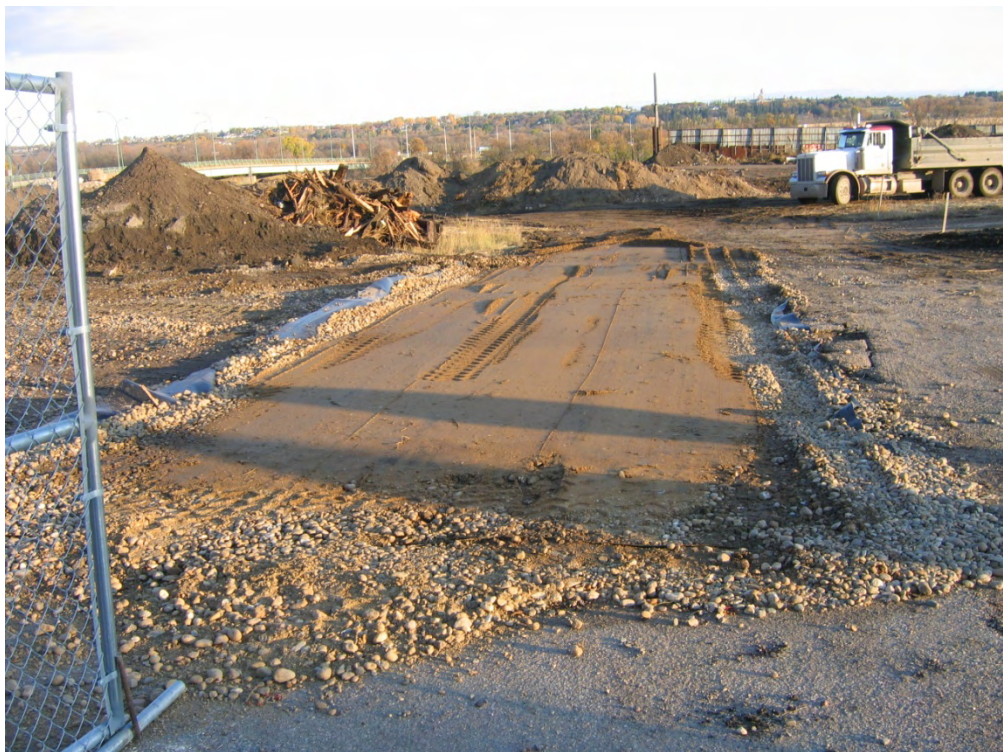
Photograph 6. Decontamination pad for vehicles. Photograph facing north. (October 2008)

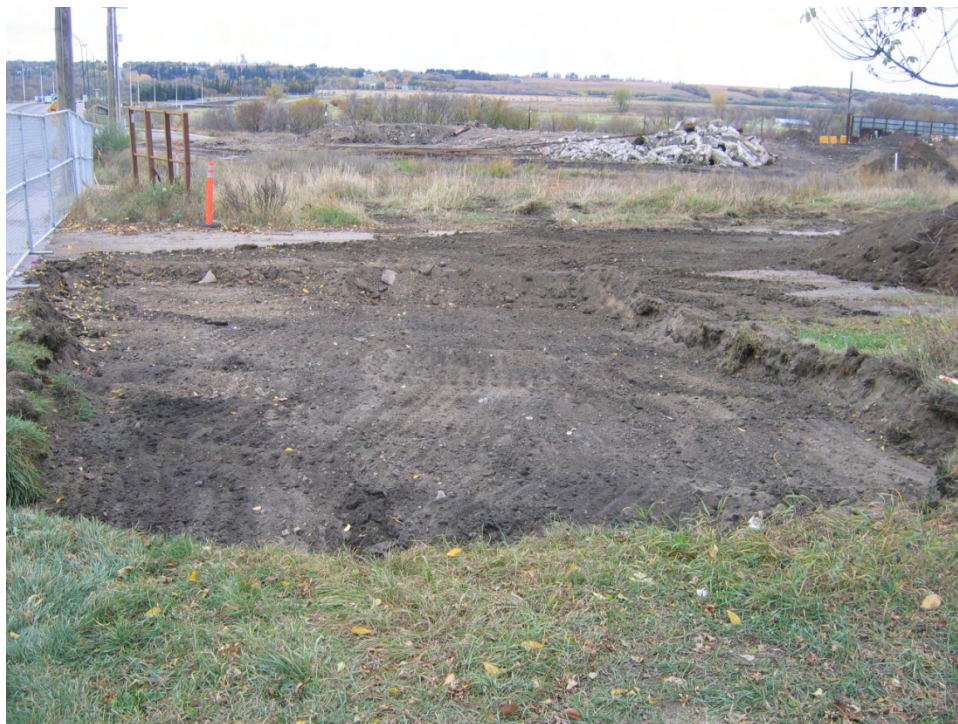
Photograph 7. Surface soil excavation on west side of Site. Photograph facing north. (October 2008)

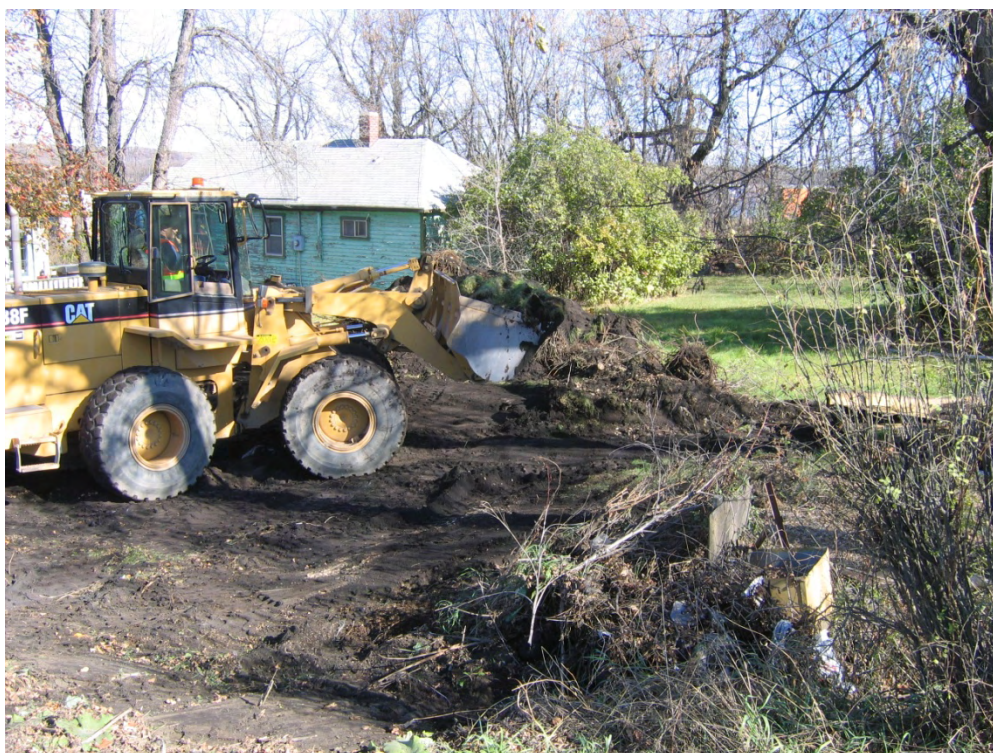
Photograph 8. Residential surface soil excavation. Photograph facing northeast. (October 2008)

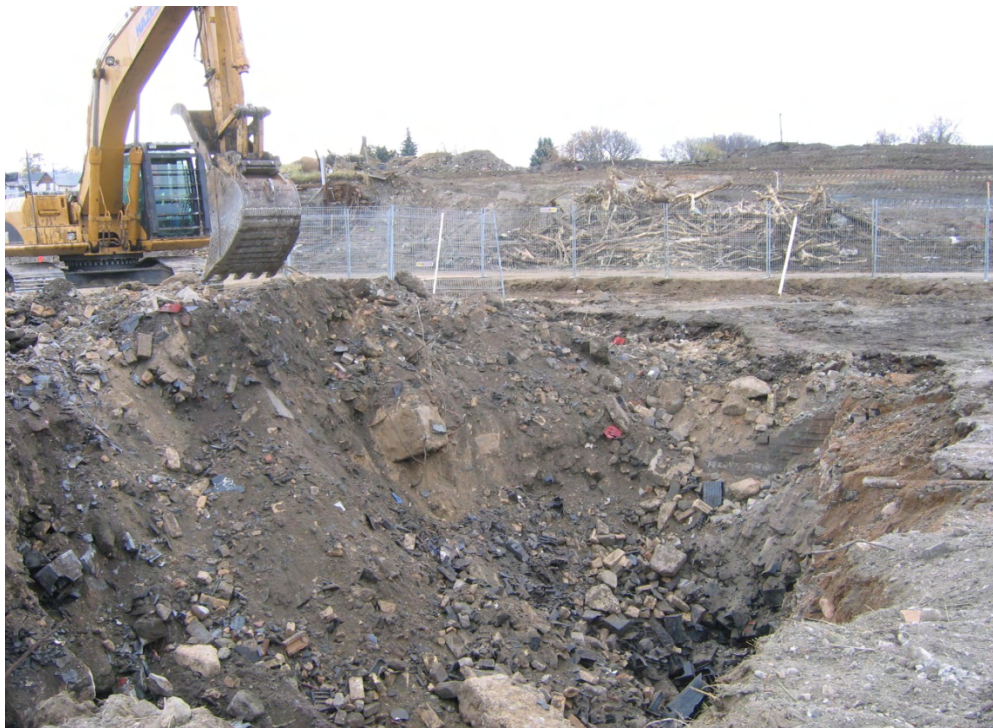
Photograph 9. Subsurface soil excavation north of Pacific Avenue. Photograph facing south. (October 2008)

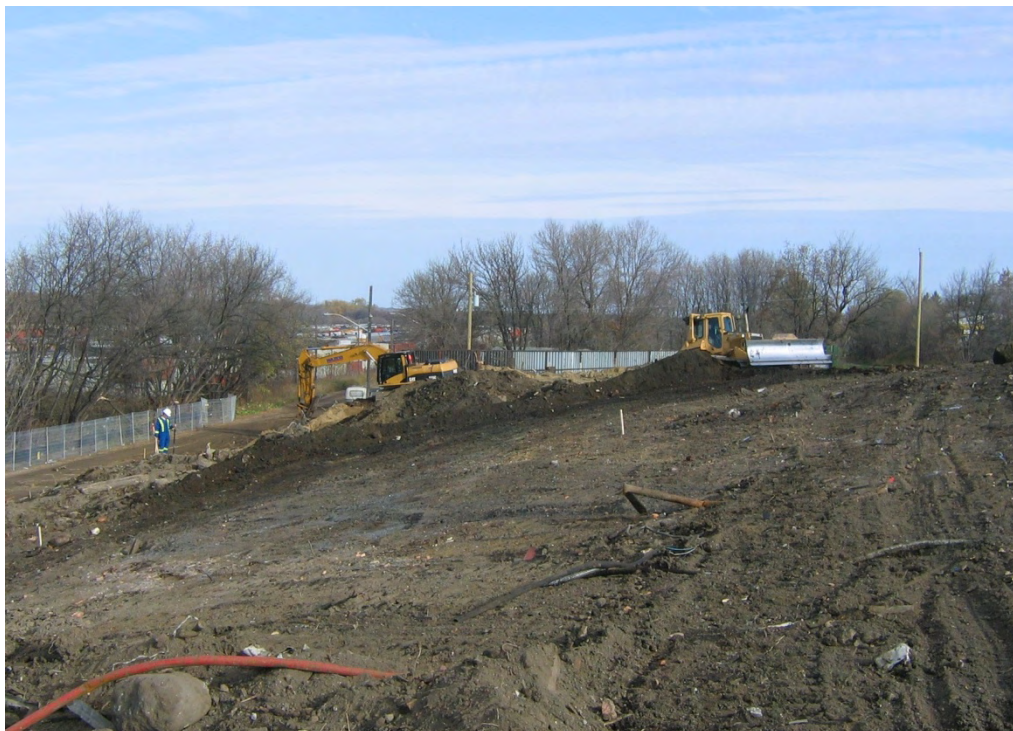
Photograph 10. Grading of soil prior to placement of engineered cap. Photograph facing east. (October 2008)

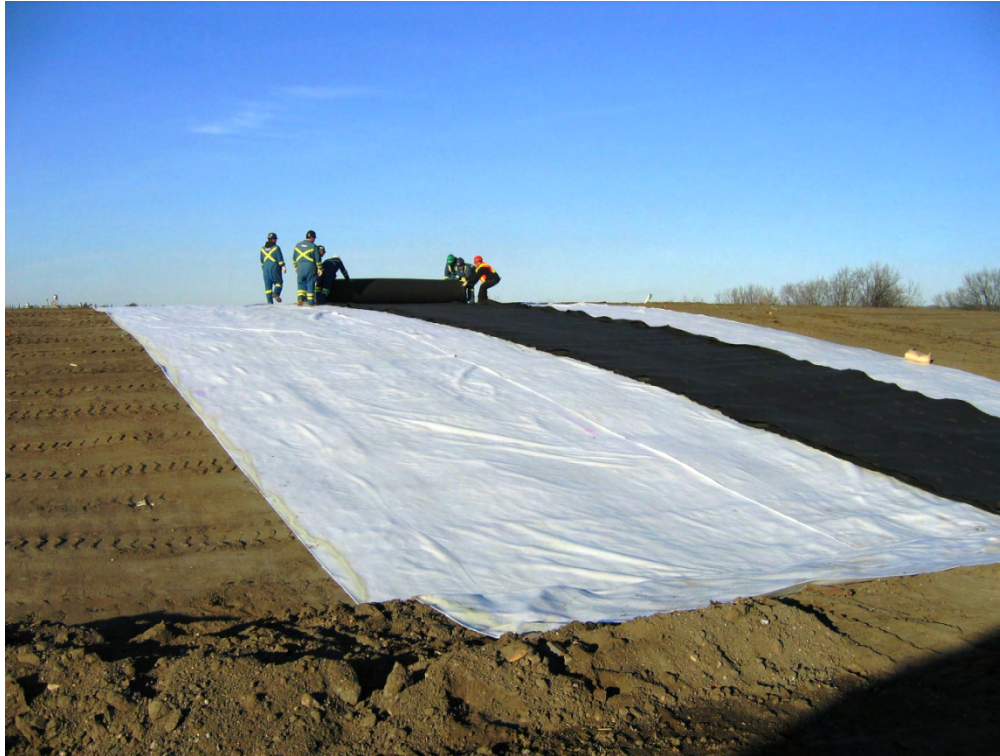
Photograph 11. Installation of GCL (white) and geocomposite drainage layer (black) over impacted soil. Photograph facing north. (October 2008)

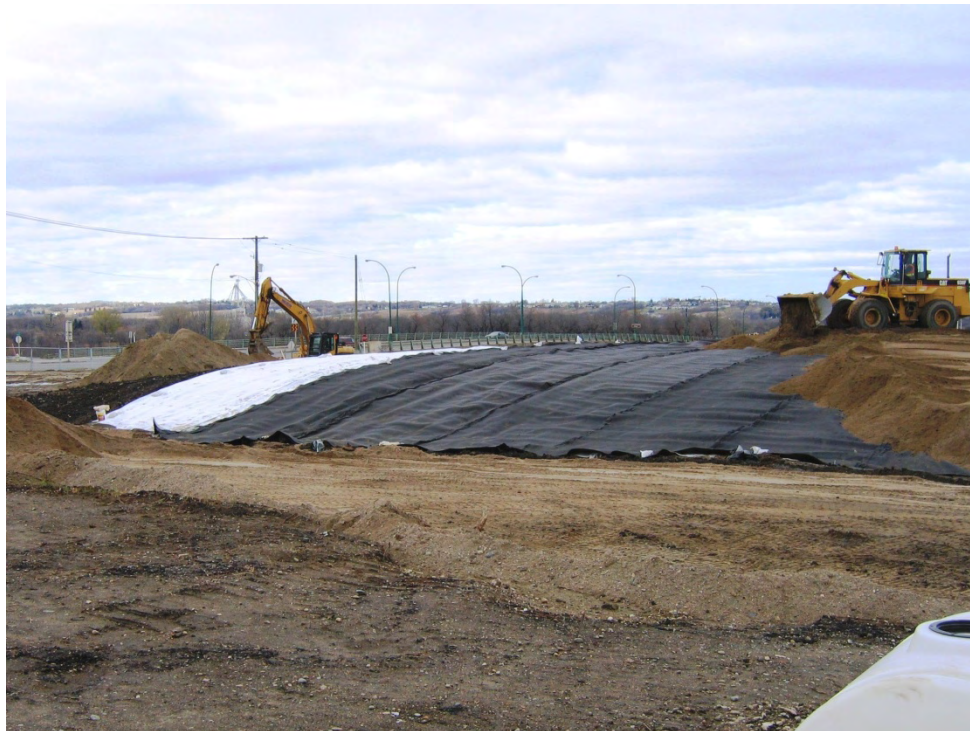
Photograph 12. Placement of protective cover material over geocomposite drainage layer. Photograph facing north. (October 2008)

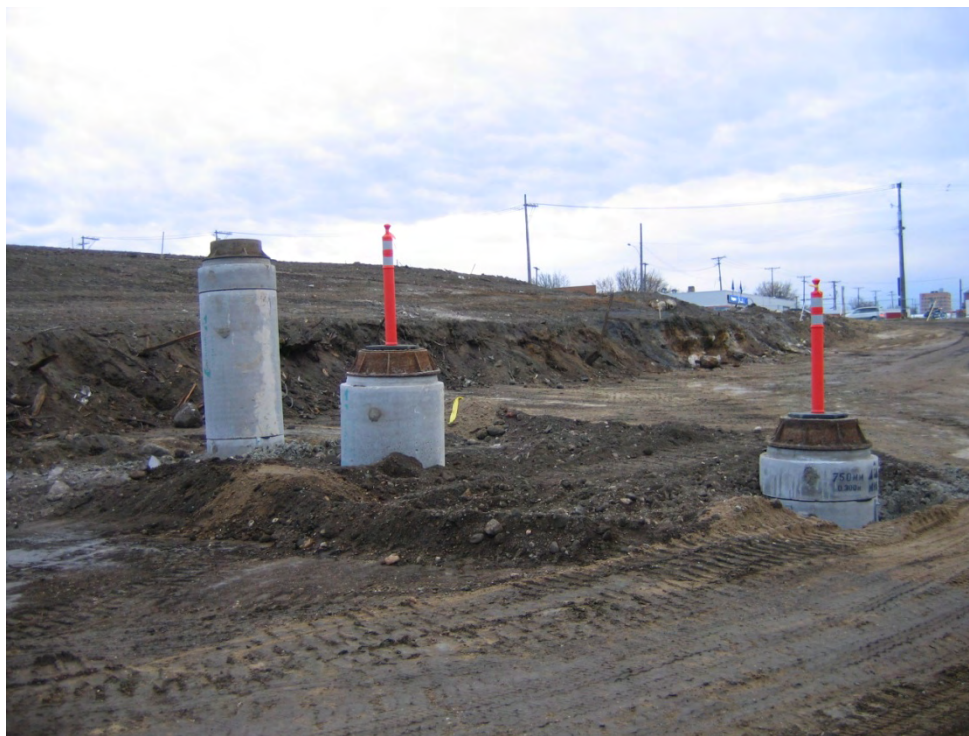
Photograph 13. Adjustment of manhole elevations on Pacific Avenue. Photograph facing west. (October 2008)

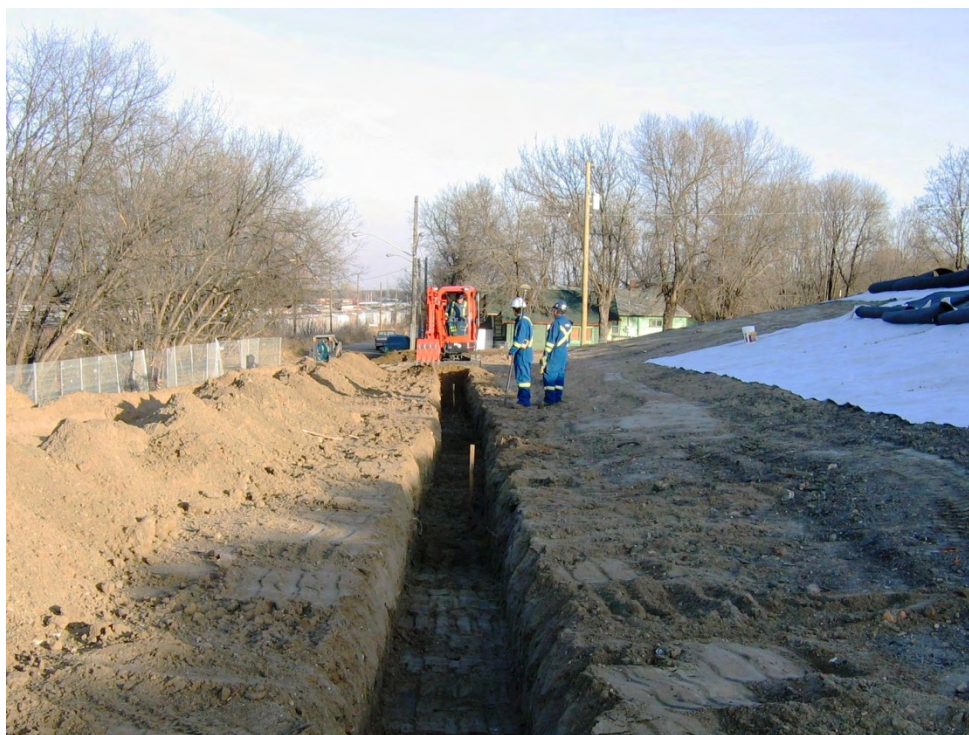
Photograph 14. Drainage trench construction along north side of engineered cap. Photograph facing east. (October 2008)

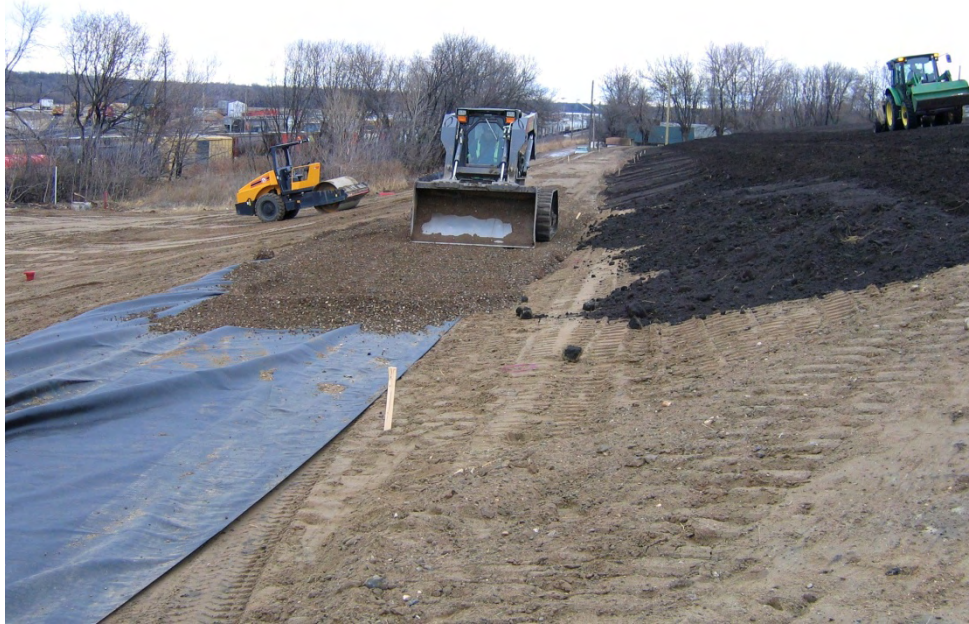
Photograph 15. Placement of walking path base material along north side of engineered cap. Photograph facing east. (November 2008)

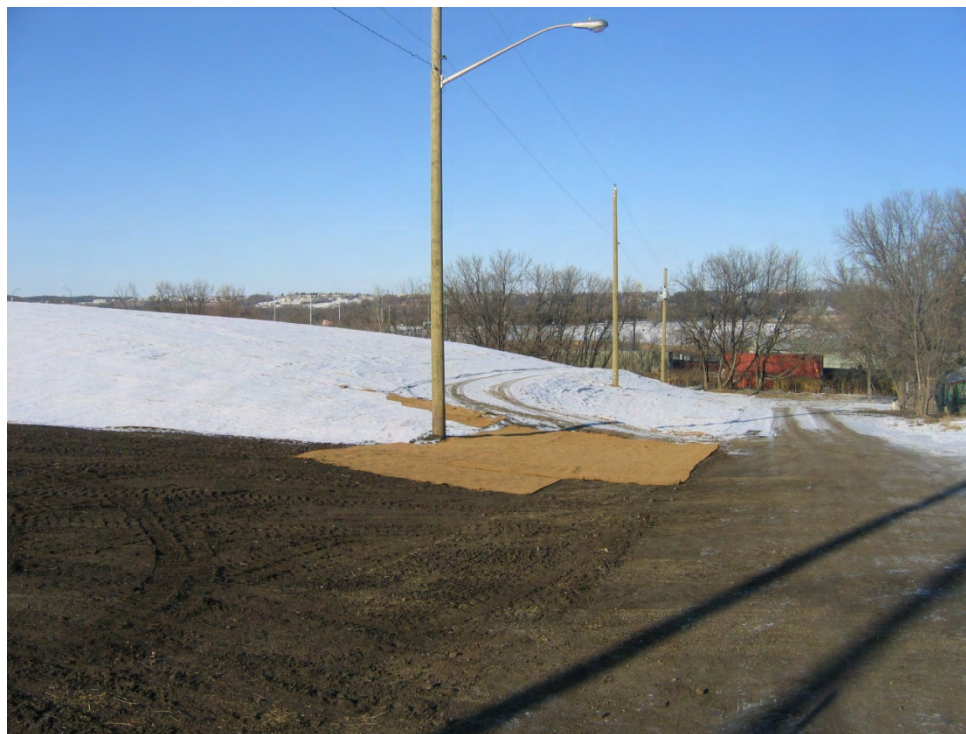
Photograph 17. Completed east side of engineered cap, including walking path. Photograph facing north. (November 2008)

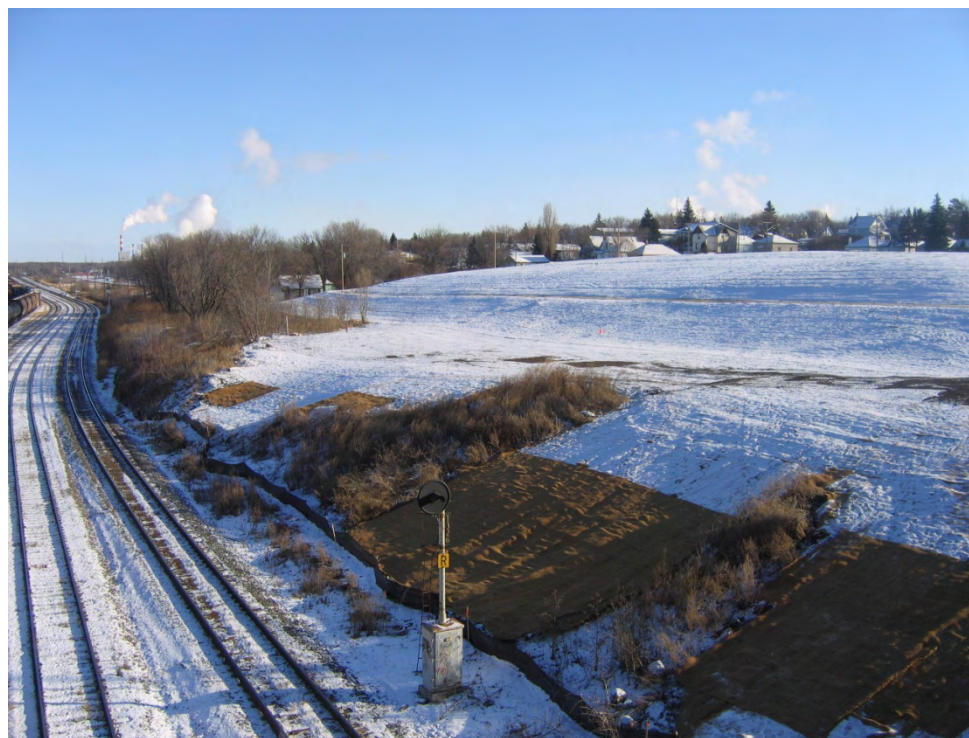
Photograph 18. Completed north side of Site, including erosion control and walking path. Photograph facing southeast. (November 2008)

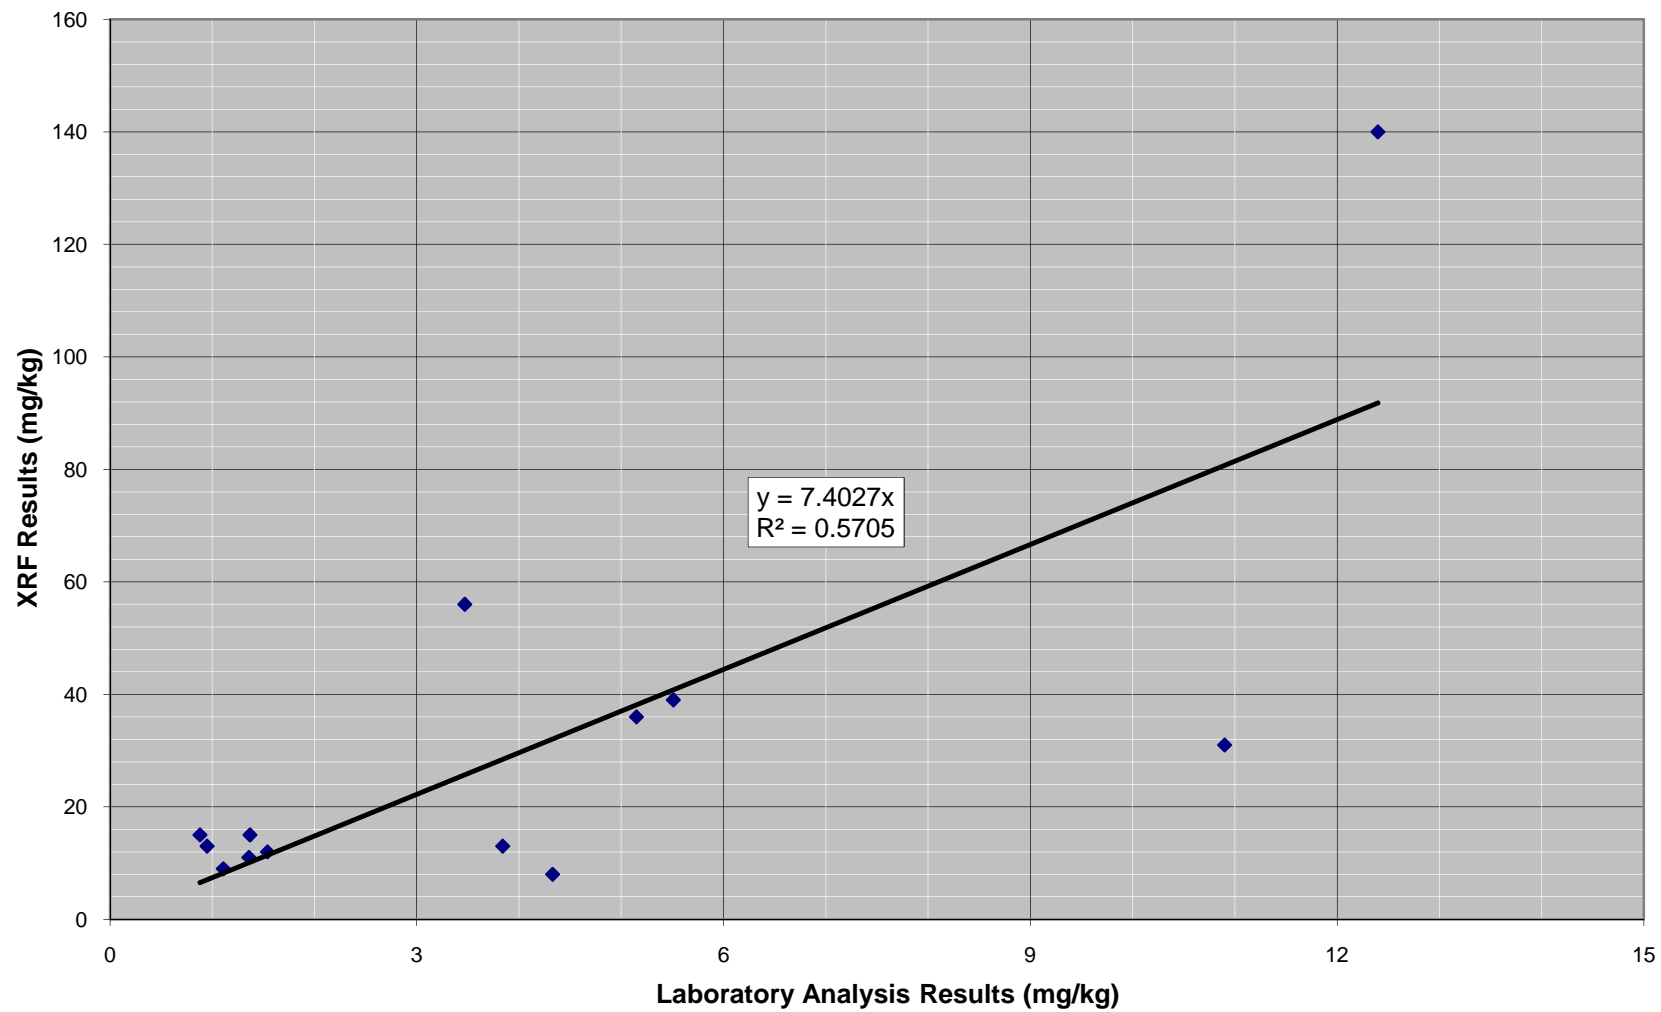
Antimony (Sb) Linear Trendline

The collected soil samples were analyzed for metals concentrations at AECOM's Edmonton facility with an X-50 Mobile XRF system. Soil samples were prepared for analysis by drying, pulverizing and sieving the samples to ensure consistent moisture content and particle size. The XRF unit analyzed the samples for 25 metals, including the metals of concern for the site; arsenic, antimony, iron, lead and manganese. Based upon the laboratory analysis of 33 selected soil samples, or 10 percent of the total samples analyzed by the XRF unit, a correlation between the XRF readings and the laboratory results was developed. The information gathered from the surface soil delineation was used to estimate soil volumes for remediation work based on metals concentration.

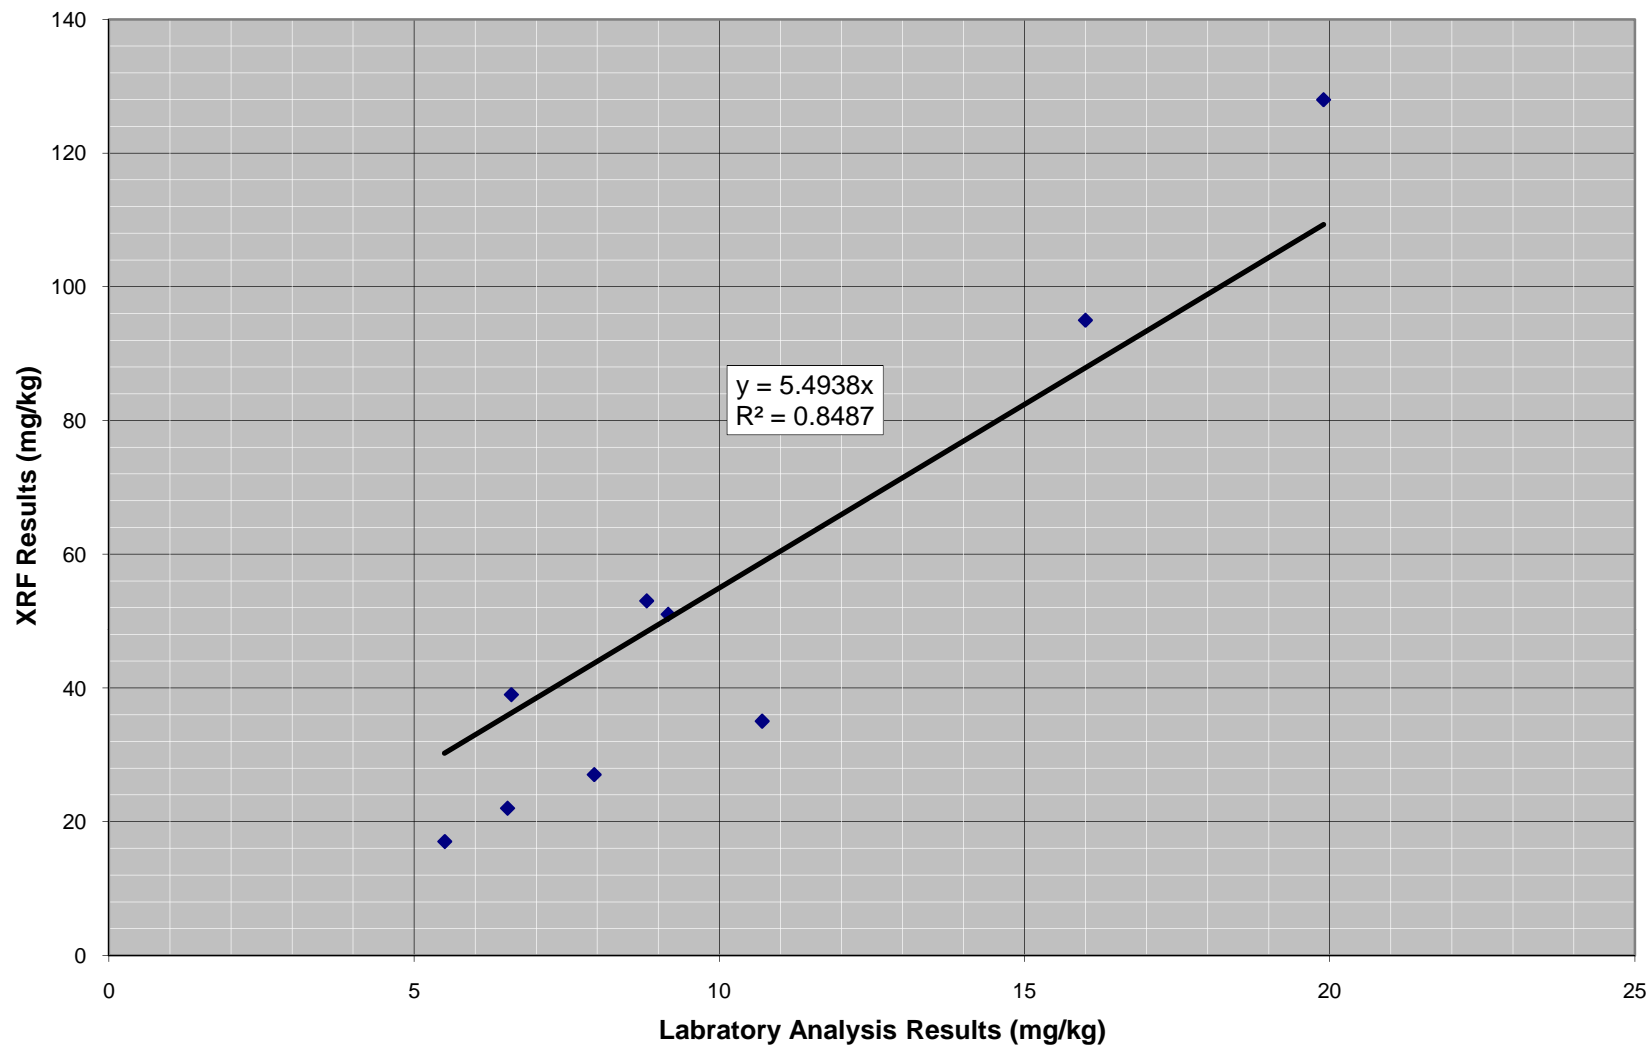
Arsenic (As) Linear Trendline
