City of Brandon

1st and Rosser Site Remediation Closure Report, Brandon, Manitoba

60116296 (100138)

February, 2010

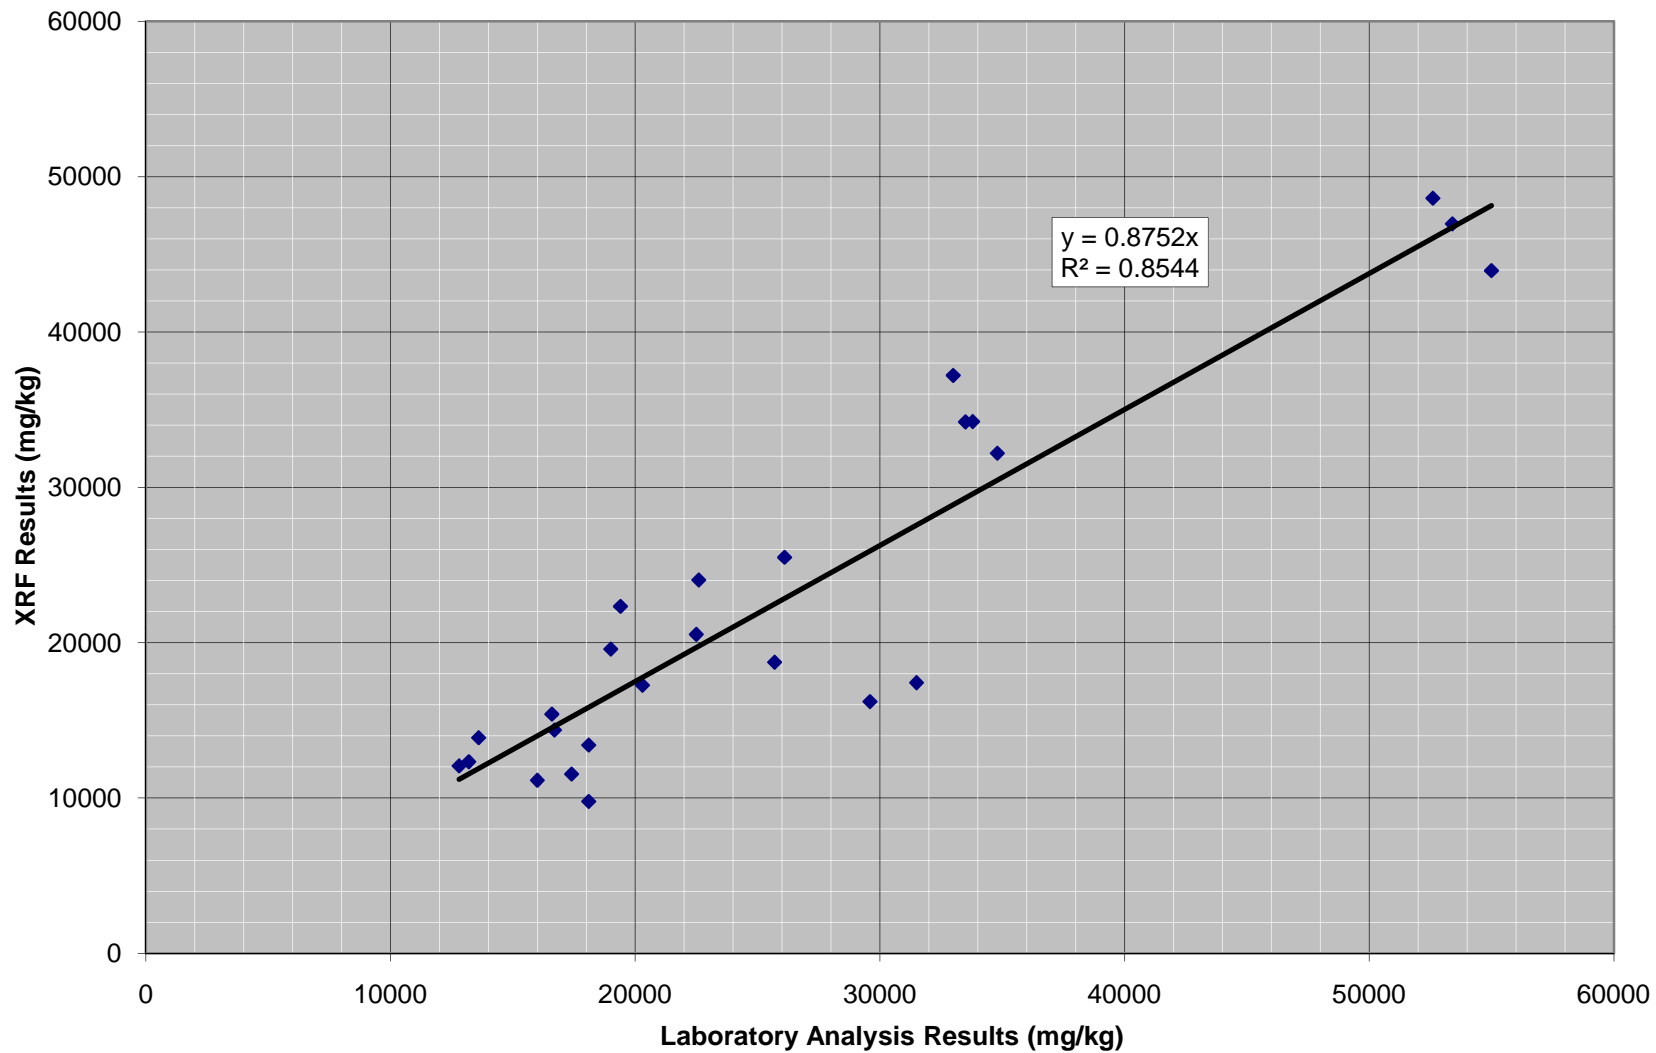
Iron (Fe) Linear Trendline

The collected soil samples were analyzed for metals concentrations at AECOM's Edmonton facility with an X-50 Mobile XRF system. Soil samples were prepared for analysis by drying, pulverizing and sieving the samples to ensure consistent moisture content and particle size. The XRF unit analyzed the samples for 25 metals, including the metals of concern for the site; arsenic, antimony, iron, lead and manganese. Based upon the laboratory analysis of 33 selected soil samples, or 10 percent of the total samples analyzed by the XRF unit, a correlation between the XRF readings and the laboratory results was developed. The information gathered from the surface soil delineation was used to estimate soil volumes for remediation work based on metals concentration.

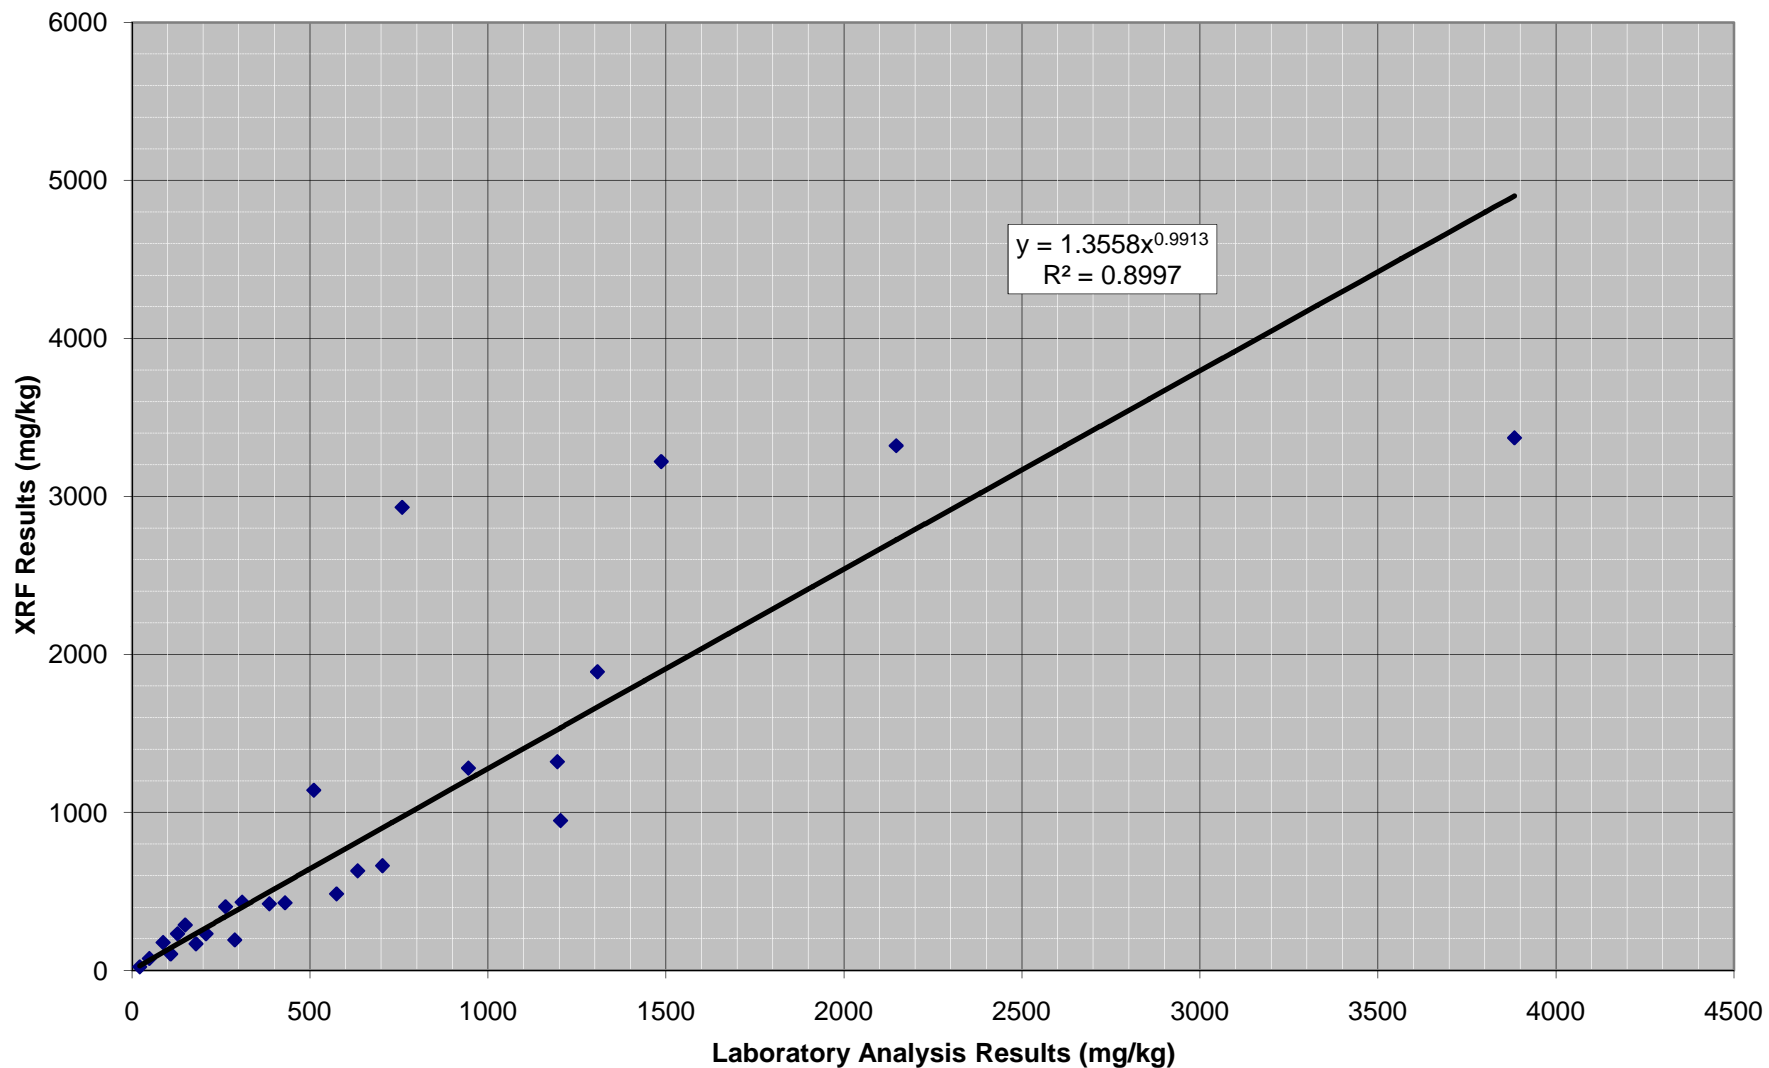
Lead (Pb) Power Trendline

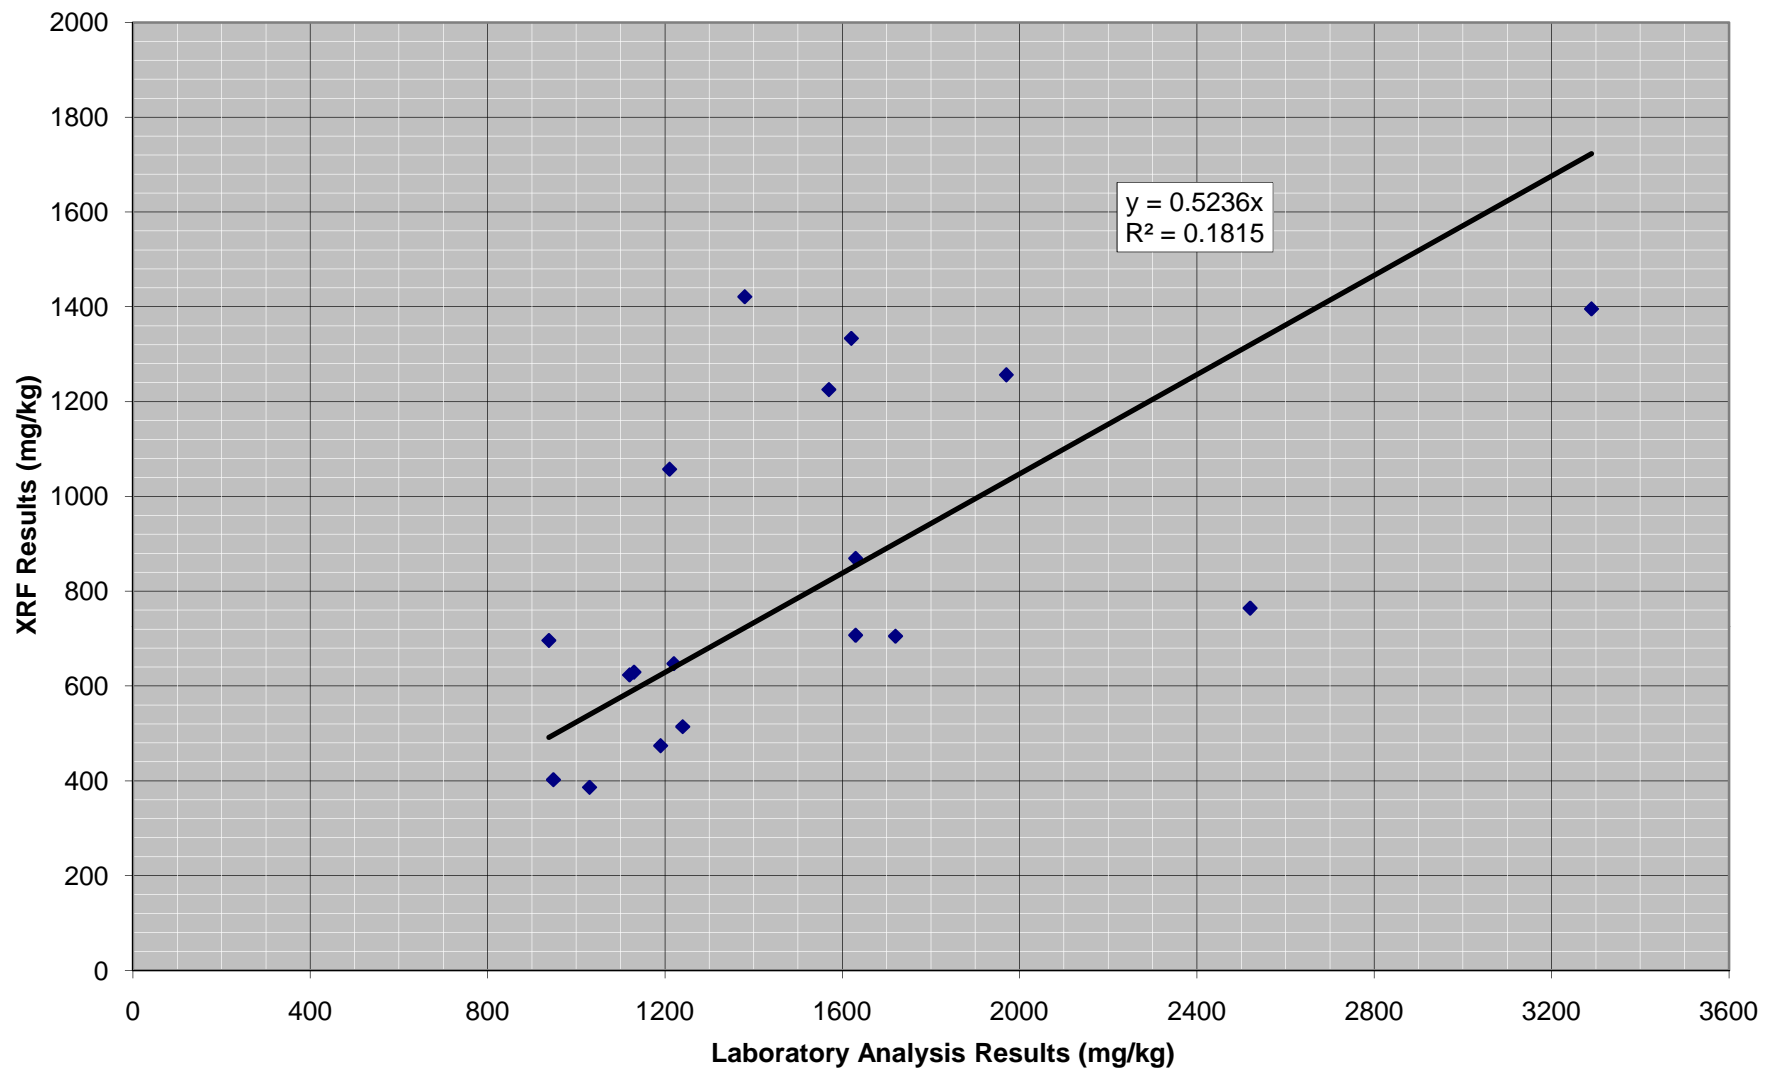
Manganese (Mn) Linear Trendline

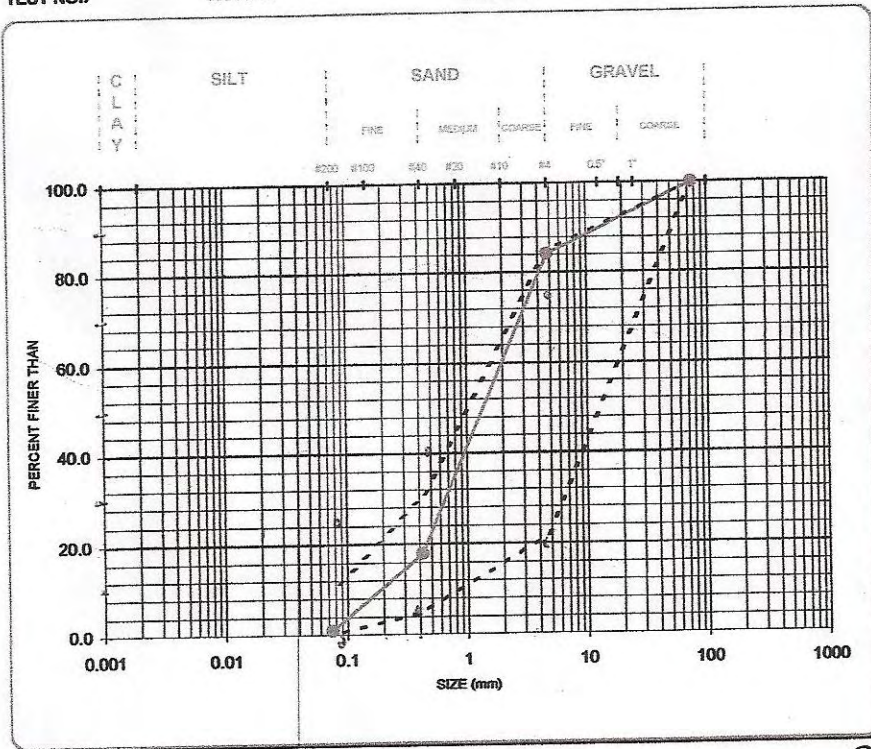
SIEVE SIZE (mm)	PERCENT PASSING	SPECIFICATIONS	
		LOW	HIGH
75.00	100.0	100	100
4.75	84.3	22	85
0.425	18.0	5	30
0.075	1.0	0	10
