Siren Test at City of Brandon, Canada

July 2003

Prepared for: City of Brandon Manitoba, Canada

Prepared by: Acoustic Technology, Inc. (ATI) East Boston, Massachusetts

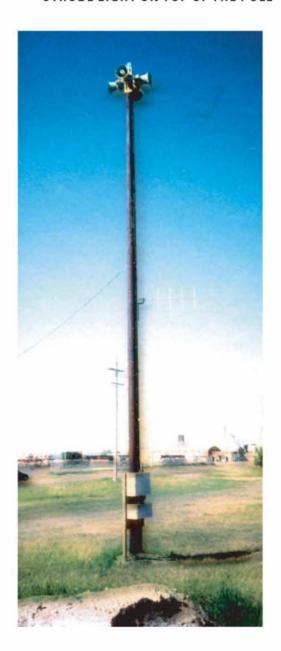
FIGURE 1 : SIREN INSTALLATION WITH STROBE LIGHT ON TOP OF THE POLE

Three (3) siren sound tests have been conducted in the City of Brandon. The dates, meteorological conditions and test parameters are set for PA and tone as discussed hereafter. The siren under test is ATI's 1600 Watt Omni-Directional High Powered Speaker Station Model HPSS16. Mounted on the top of the pole siren is a strobe light (See Figure 1). Therefore, we can assume that the strobe light is located at a height of 50 feet above ground.

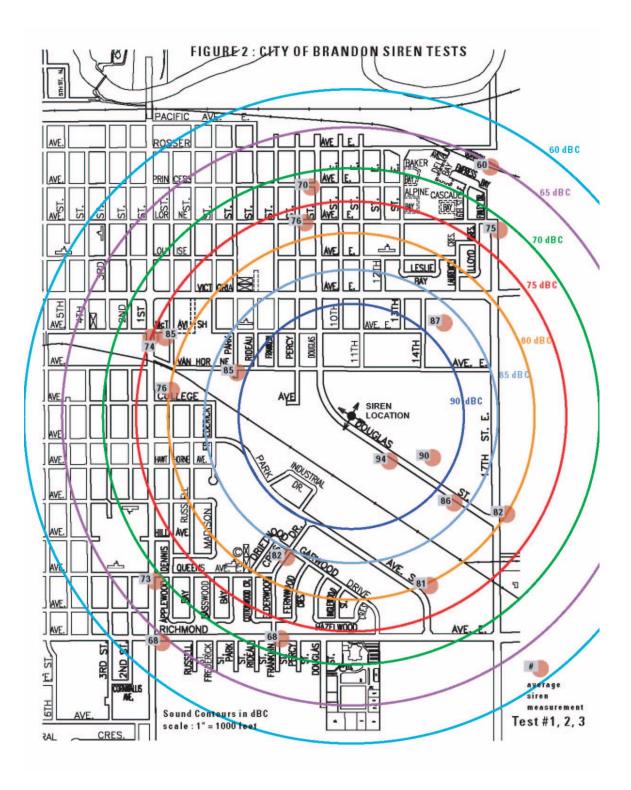
interacting with ground objects was an import factor. Noise from construction activities also affects the PA audibility. The correlation between the predicted siren contours and siren measurements is shown in Figure 2.

The same observation made in regards to strobe lights are the same in Test 1. The strobe lights are clearly seen throughout the distance if there is clear visibility. Also, concerning the PA, the same comments made on Test 1 can be extended to Test 2. Regarding the ambient noise, other noise sources were added on the ones mentioned on Test 1. These are wind generated noise and lawn mower noise. Data has been taken from Test 2 is compared to the predicted siren contours in Figure 2.
