Eastview Landfill 2022 Annual Report

The 2022 Annual Operations Report is provided to fulfill the City's License requirement to annually report on operations and monitoring at the Landfill. This Annual Operations Report covers the period from January 1, 2022 to December 31, 2022.

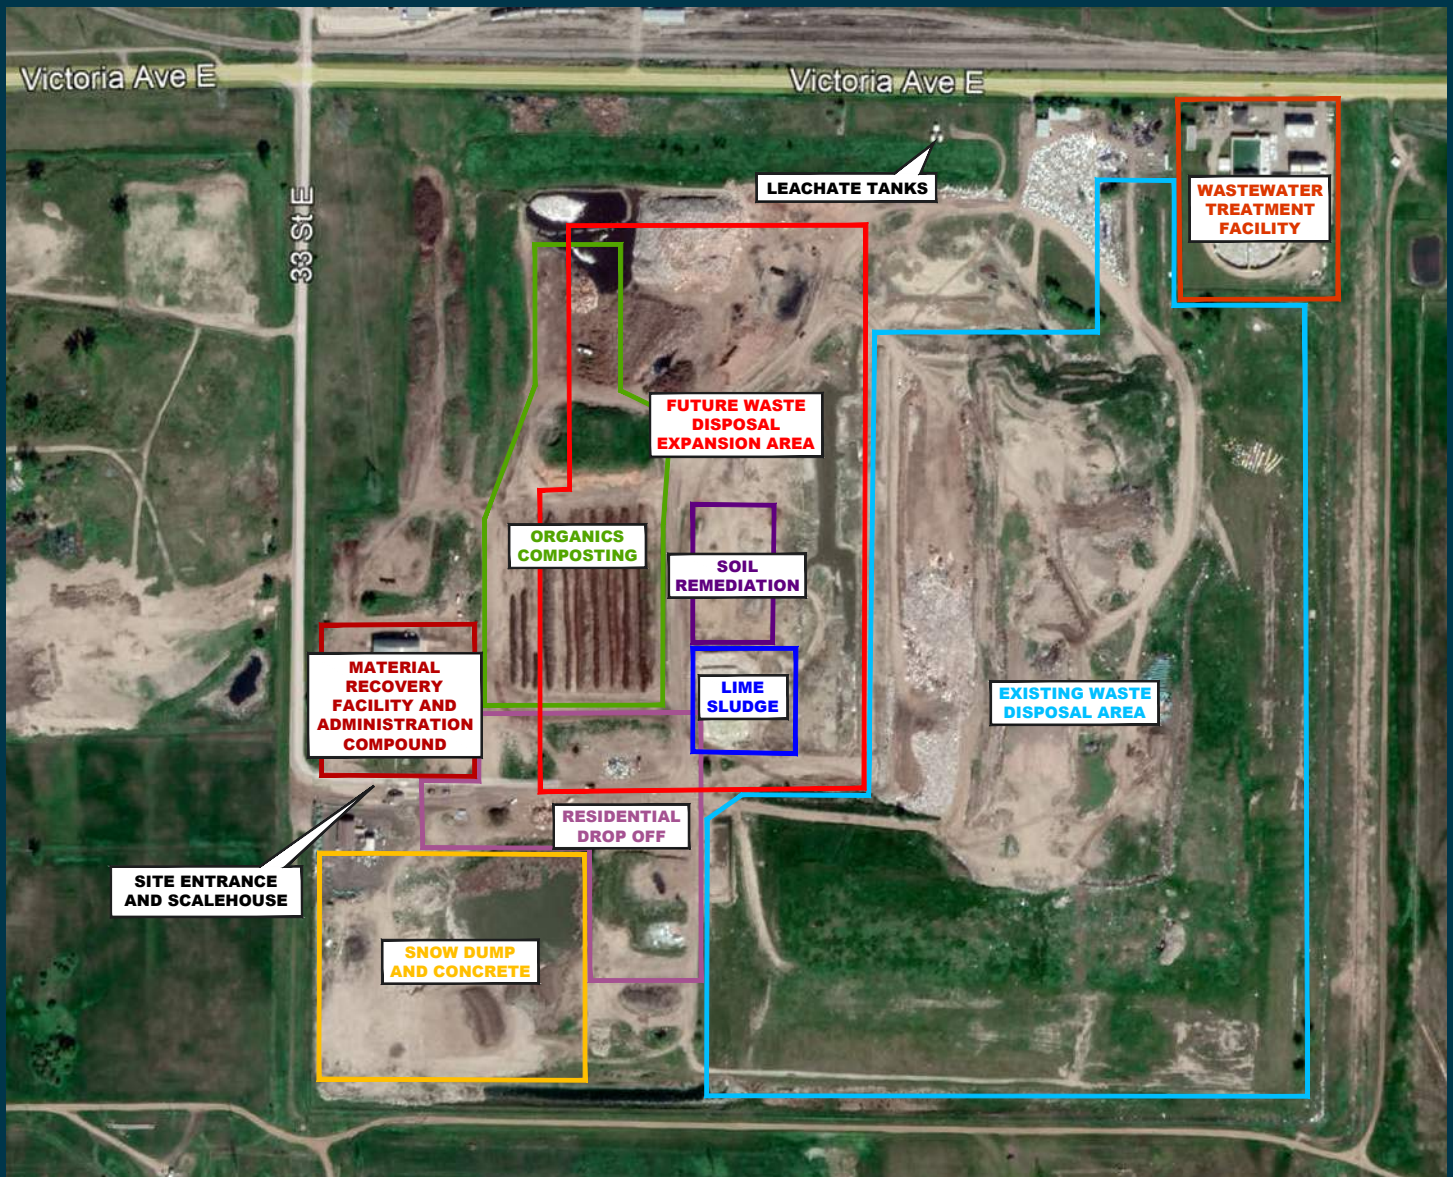
Figure E-1: Landfill Site Plan

The areas of the Landfill are shown in Figure E-1.
