Eastview Landfill Site

2019

Introduction

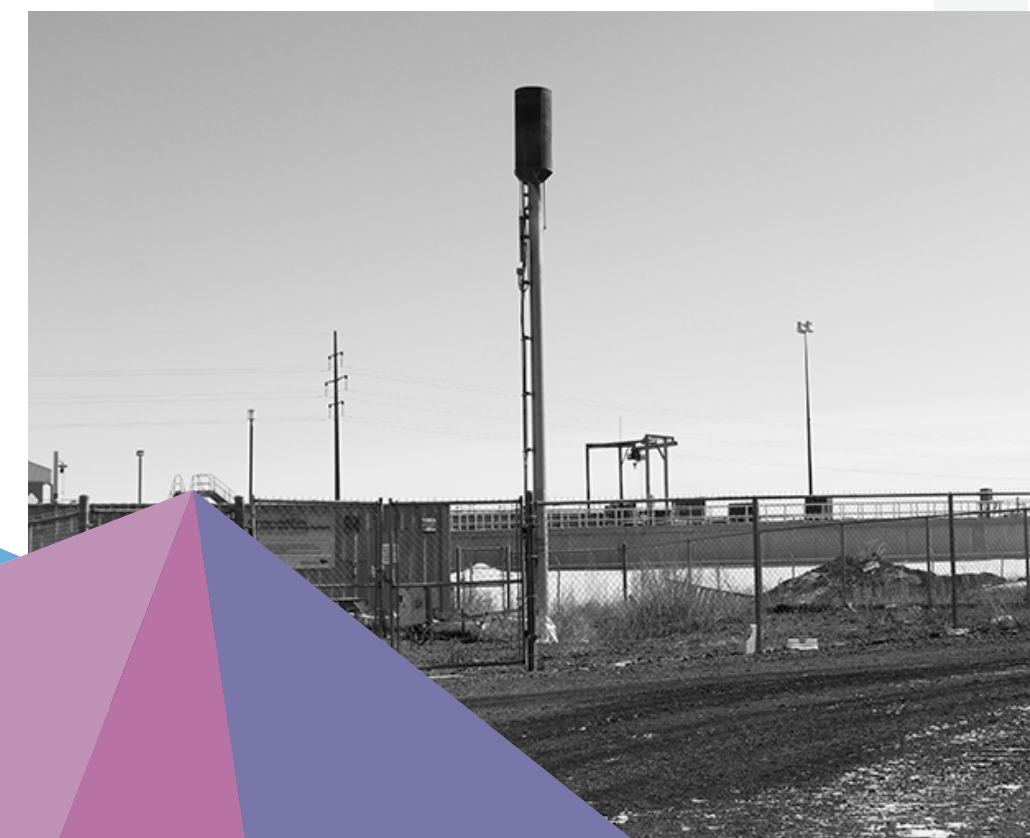
Annual Landfill Gas Generation

In 2019, we collected and flared 75,138,253 (scf) of landfill gas. This equates to approximately 12,404 tonnes of CO2 being diverted from the landfill site during the year, which is a slight decrease of 8 tonnes from 2018.

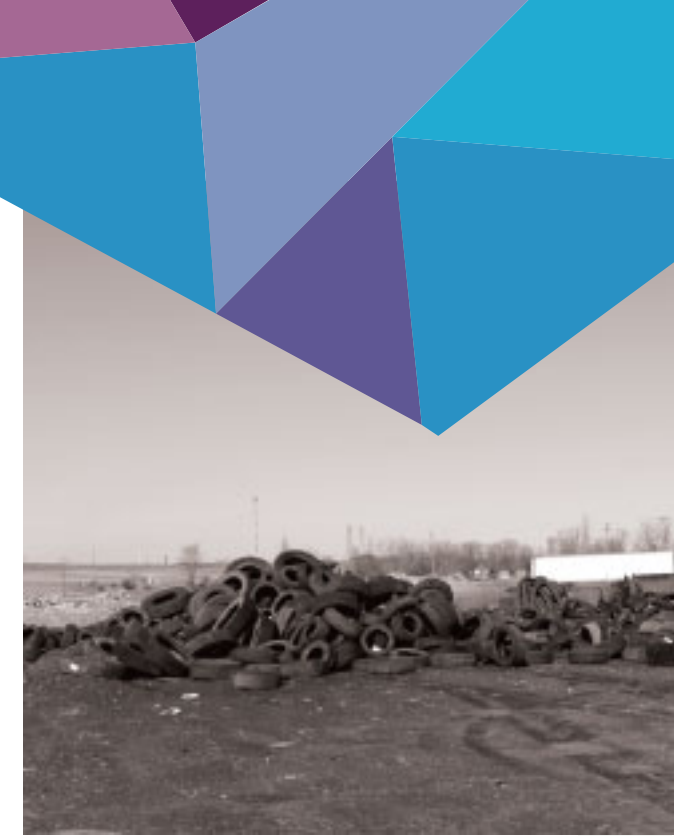
Annual Trend of Scrap Tire Collection & Removal (Tonnes)

Tire Stewardship Manitoba was launched in April of 2008 as a not-for-profit organization to help manage the problem of scrap tires. In 2019, 235.61 tonnes of scrap tires were removed from the Eastview Landfill Site.

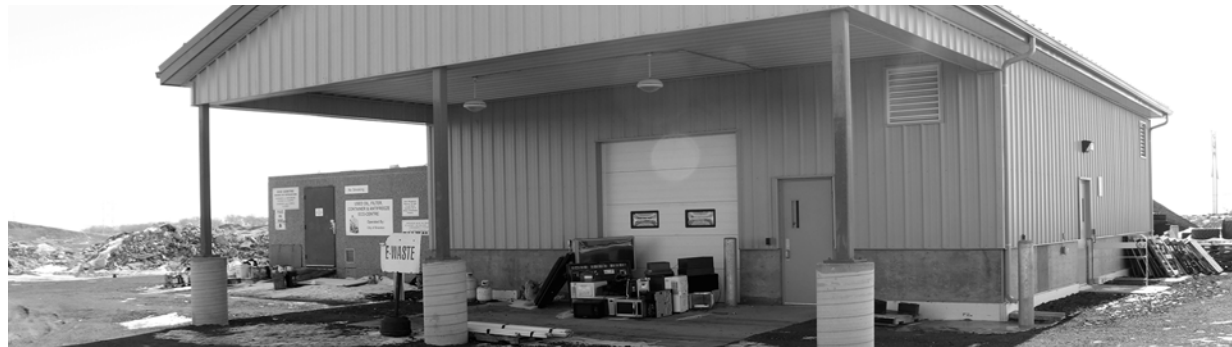
Annual Trend of HHW Material Collected (Tonnes)

2016	2017	2018	2019
Annual Total	51.92	35.56	25.65	30.78
