Eastview Landfill 2023 Annual Report

The 2023 Annual Operations Report is provided to fulfill the City's License requirement to annually report on operations and monitoring at the Landfill. This Annual Operations Report covers the period from January 1, 2023 to December 31, 2023.

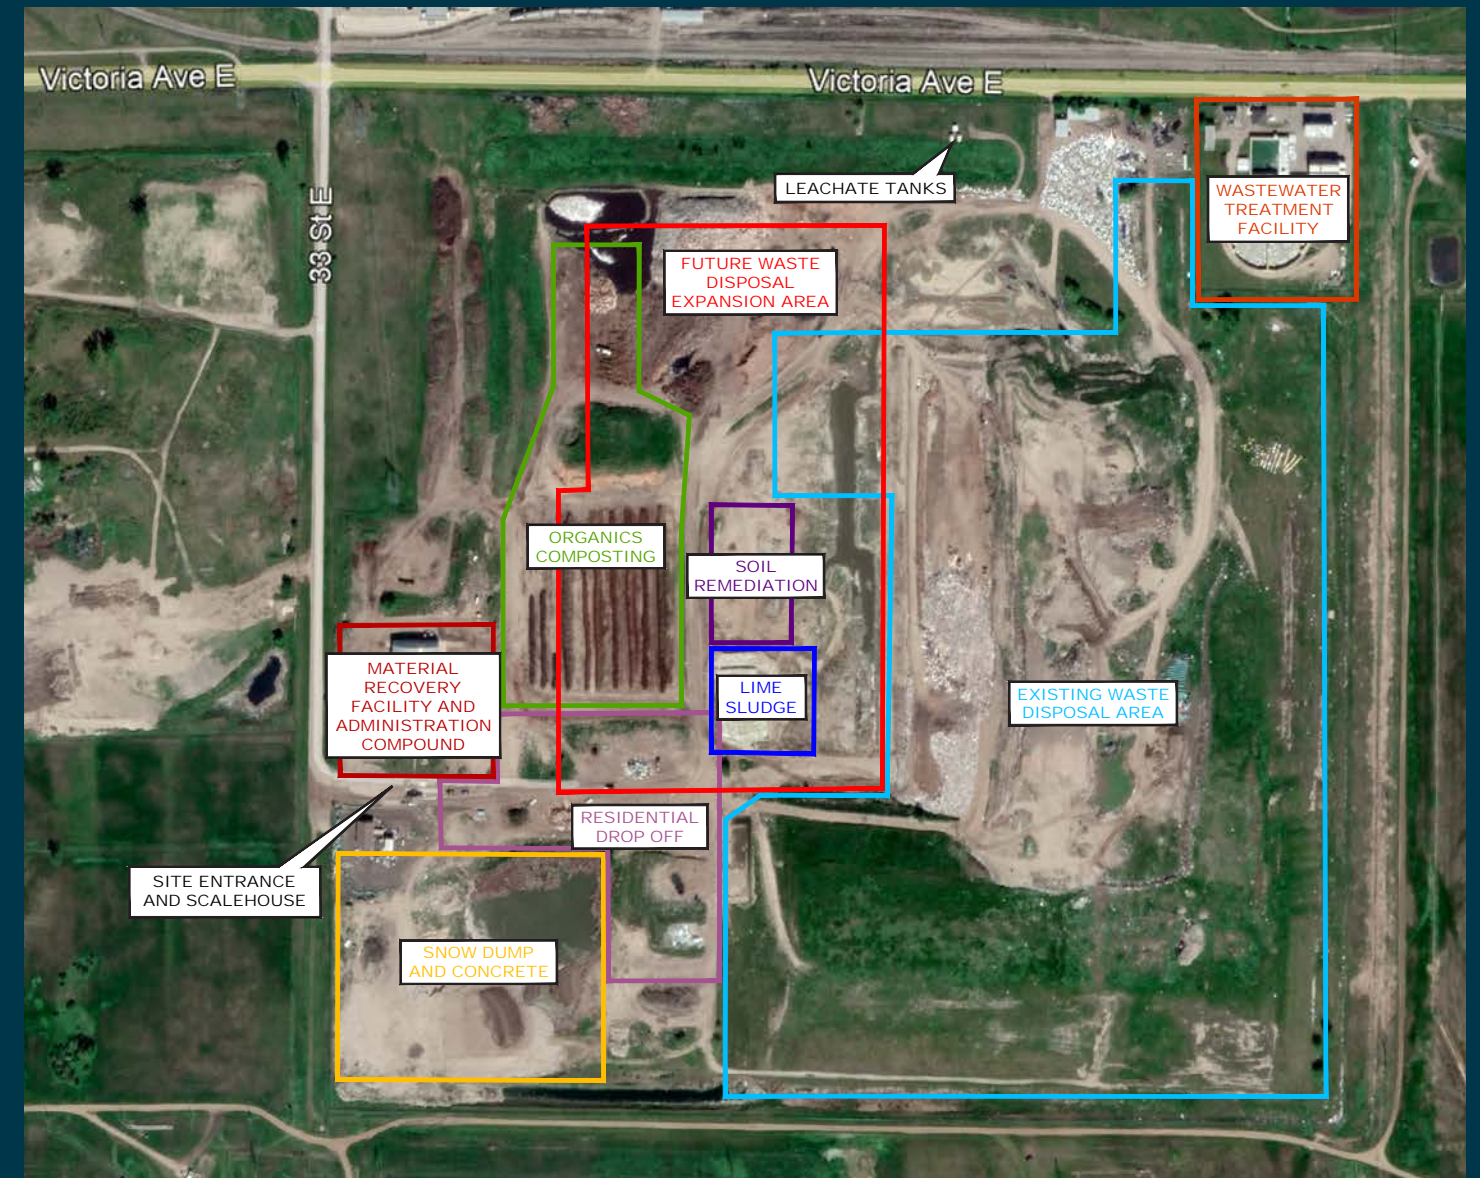
Figure 1: Landfill Site Plan

Site facilities include:

- Former and active disposal areas.
- Commercial and residential disposal areas.
- Scale and scale house.
- Snow removal dump site (City use only).
- Clean fill disposal.
- Concrete disposal area.
- LFG collection system.
- Material Recovery Facility (MRF).
- Designated stockpiles for metals, propane tanks, tires, yard waste, and branches.
- Freon device removal depot.
- Eco-Centre for used oil, filters, and containers.
- Tree and wood chipping.
- Composting.
- Electronic waste (E-waste) depot.
- Household hazardous waste (HHW) depot.

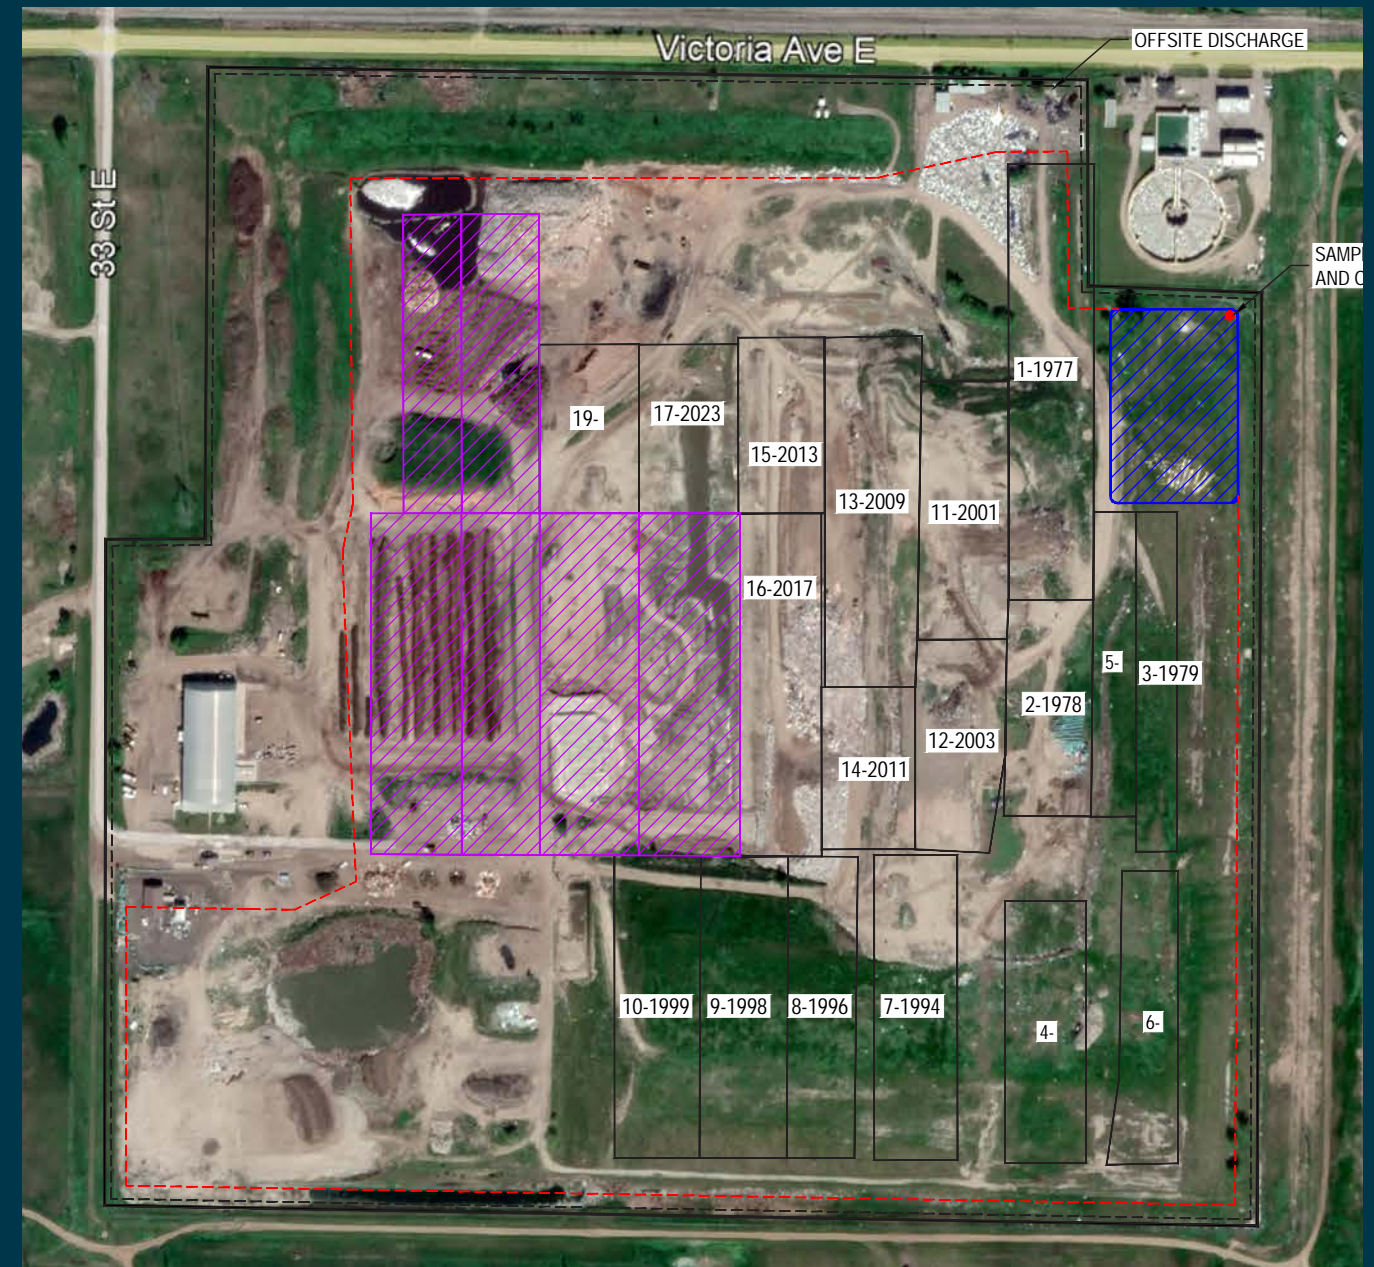
Figure 2: Landfill Cell Design Master Plan (KGS Group 2017)

The following summarizes the developed and undeveloped areas within the Landfill design footprint, also shown on the KGS Group Cell Design Plans (2023), shown as Figure 2.

- Cell 1 to Cell 6 – Developed along the eastern edge of the Landfill, unlined cells from the 1970s and 1980s that have been closed and capped.
- Cell 7 – Developed in 1994, a Geosynthetic Clay Liner that has been closed and capped.
- Cell 8 to Cell 12 – Developed between 1996 and 2003, High-Density Polyethylene (HDPE) lined cells that have been closed and capped.
- Cell 13 to Cell 16 – Developed between 2009 and 2017, HDPE lined cells that are currently in use. Cell 13 and Cell 14 reached capacity in 2023 and Cell 15 has approximately one year of capacity remaining.
- Cell 17 – Developed in 2023, an HDPE lined cell that is currently in use.
- Cell 19 – Planned for development in 2024, an HDPE lined cell.

Leachate is collected from lined disposal cells. There are nine manholes located around the perimeter of the waste disposal areas. Leachate is pumped directly into the manholes and passes through a meter so that the City can measure leachate flow. Leachate is then pumped into leachate storage tanks located directly west of the old scale building. Figure 2 shows a map and utilization plan for the Landfill.
