Eastview Landfill Site

900 Richmond Avenue East
Brandon MB, R7A 7M1

2021

Introduction

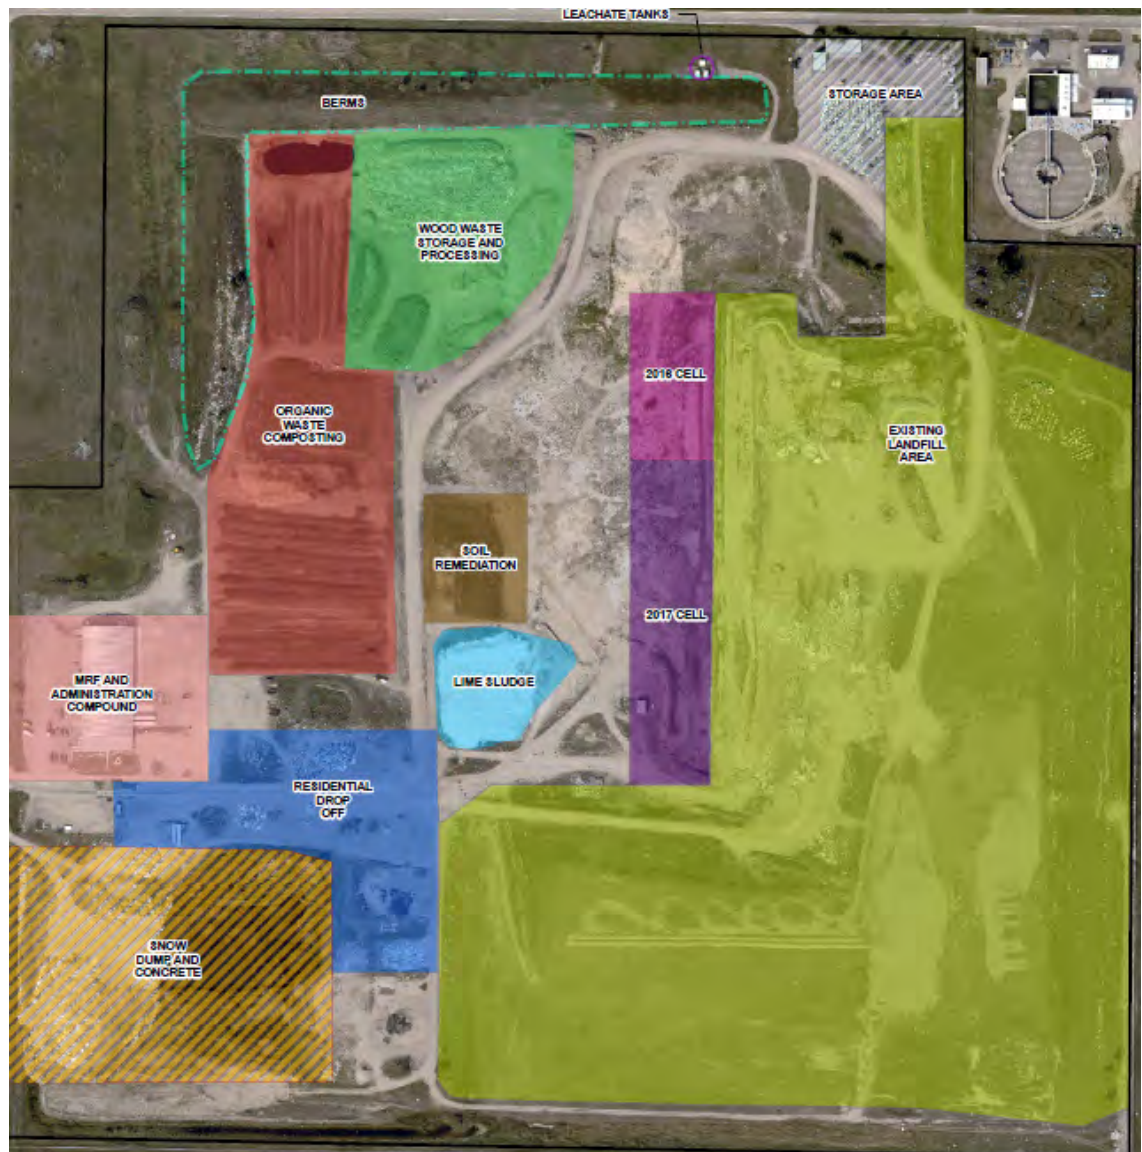
Beside is a copy of the landfill section map.
